# WWII BATTLEFIELD RESEARCH AND PRESERVATION GROUP

B-17G crash site concluding findings of Aircraft #44-6141, "Sneakin Deacon"  
United States Army Air Forces, 384th Bomber Group, 544th Bomber Squadron  
Date Found: 14 March 2018. Identified June 2020,  
Northwest of Weicherdange, Luxembourg

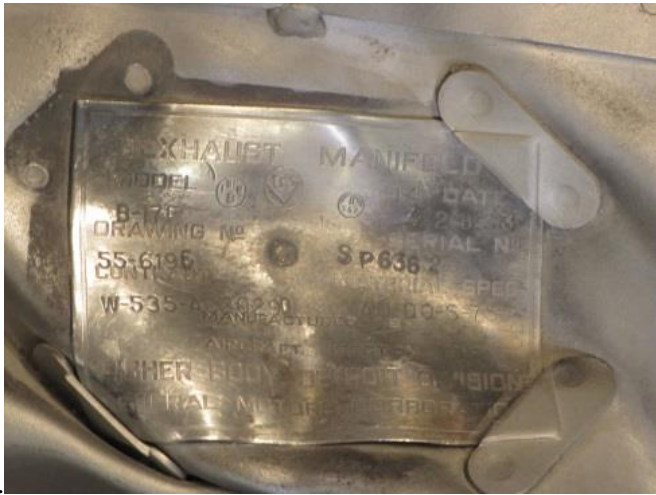
Figure 11-1, Clervaux Museum, WWIIBRPG

Mr. Diederich explained that his father had been there during the salvage operation, spring of 1945 when a salvage company came to pick up the engines. The company had also roped off the area warning locals to stay away for munitions were around. He too had in his possession several pieces from the site. One-piece found in the foundations of a shed he and his father was tearing down to rebuild, it was a piece of the airframe. He also had one of the large fuselage armor plates. Also asked if he had recovered any data plates with numbers or dates, because he had found a piece with the data plate on it saying B-17F and dated 1943 he said that the plane was a B-17F. He said the tag was at the local military museum in Clervaux.

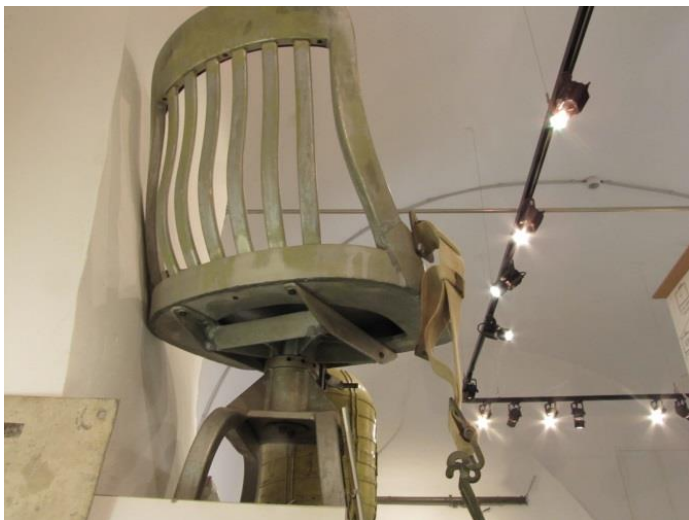
Figure 11-3, Clervaux museum, WWIIBRPG

At the museum, sure enough, there was a piece of the exhaust collector with the plate and a card saying “ Engine piece, B-17F, crashed near “Wolfshof” Eselborn, 30 Nov 1944”, just like written in the ET Melcher book. A couple of issues with that were, one, the piece came from Weicherdange, not Eselborn and two, the piece does not identify the aircraft, type, or date built/delivered, only that this exhaust collector was first built for a B-17F, April-28 1944. Engine swapping occurred almost daily, as many F models were cannibalized, used as parts surplus from summer 1944 onward as they were old stock. The other confusion was that another piece was a chair, labeled as navigator chair, B-17F Weicherdange 3 November 1944. The chair was actually a radio operator’s chair.

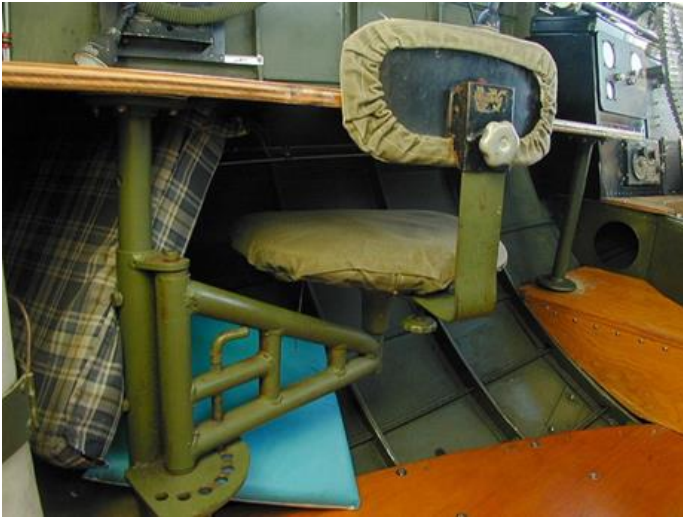
Figure 12-1, web

This is a navigator's position and chair, as seen at its station, as compared to a radio operator's position in the next picture.

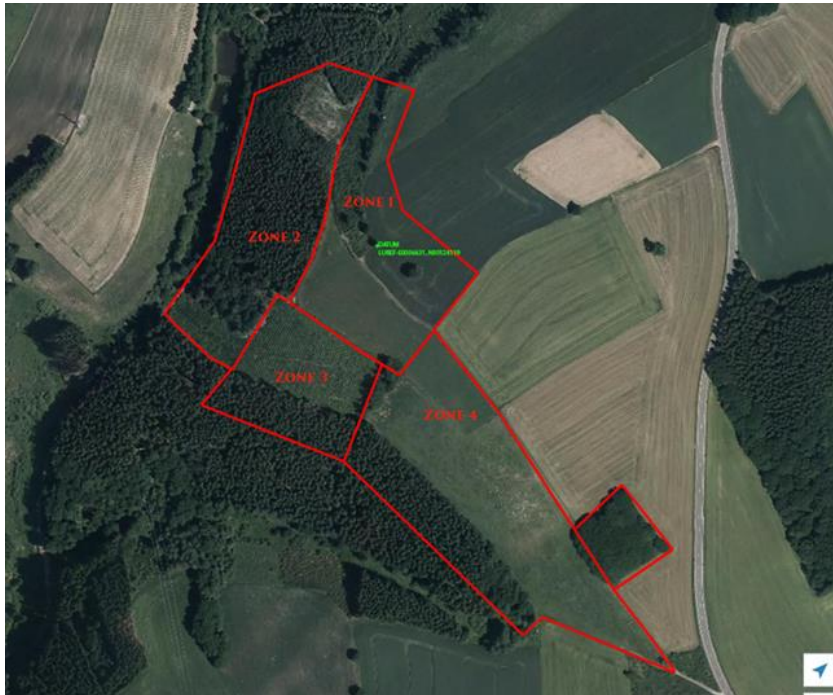
Figure 14-1, Zone search areas, Luxembourg Geoportal, (WWIIBRPG)

The general research area containing aircraft wreckage was separated into four separate zones. The zones number Z-1 – Z-4. The zones only cover the immediate area that is in scrutiny and research around the hill Bircherknupp.

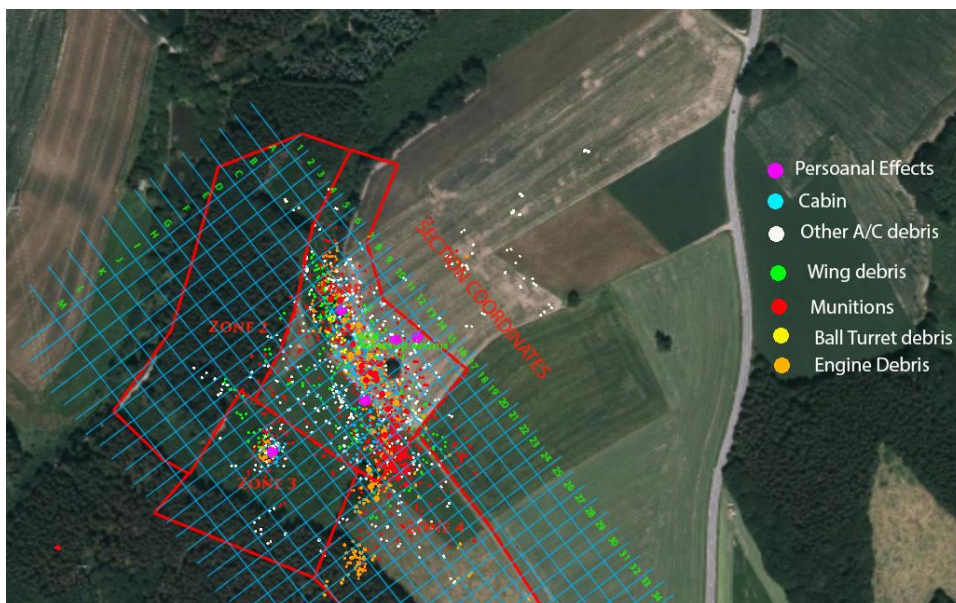
Figure 14-2, Overlay grid on top of Zone 1-4, Luxembourg Geoportal, (WWIIBRPG)

To show wreckage scattering patterns and to record significant artifacts a virtual grid-overlay covered all zones. The grid was set up with vertical and horizontal grids being 10 meters square and a number/letter system used. The starting grid was given A-1 at the farthest point North (numbers) based on irrelevant wreckage fragments found and continued to the South, and letters East-West direction.

The overlay also aids in tracking different types of material/evidence, as to what area was found and if similar material is in the associated area, revealing the sections of the aircraft that had come down and what direction it came from. It was the thought these findings might support identifying the crash to be that of 43-38911. Documenting of significant artifact finds is with LUREF, GPS readings, using a Garmin GPSMAP 64. A datum point was established at (66390E, 124037N) the corner of the crop field bordering the grass field and fence line road.

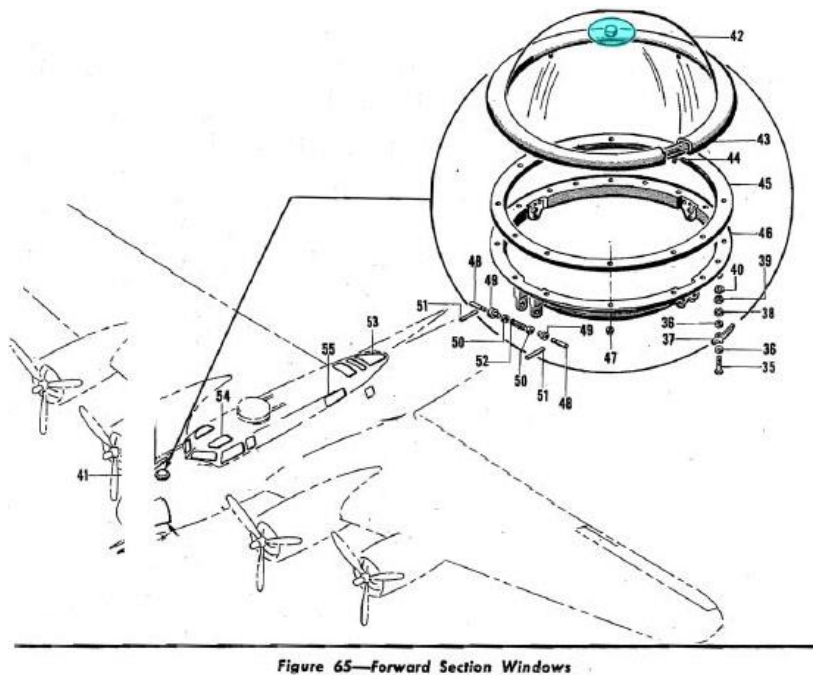
Figure 16-2, AN 01 20EG-04, Diagram of the nose section shows the Navigators dome in the Bombardier, Navigators section of the plane. Found in Zone-4.

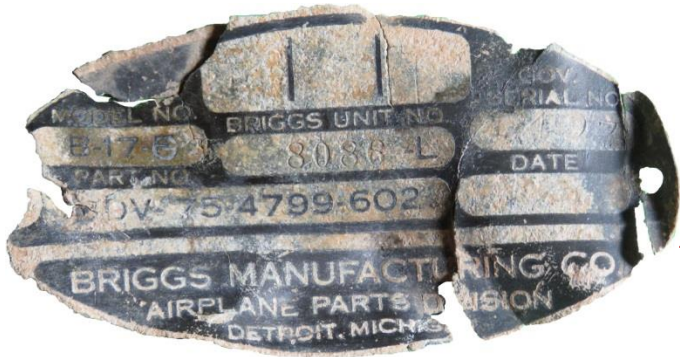
Figure 19-1, WWIIBRPG

In mid-summer 2018 the question of whether it was a B-17 G or F was finally answered with the discovery of the wing data plate. The plate is from the port side outboard wing as indicated by the unit number 8088-L MODEL B-17G.

Data plate – Briggs Manufacturing Co.

MOD B-17G, BRIGGS UNIT No 8088L, GOV SER# 1.497

PT No-3BDV-75-4799-602, DETROIT MI, FIG-11, PG24 [LH]DOOR ASSY.]

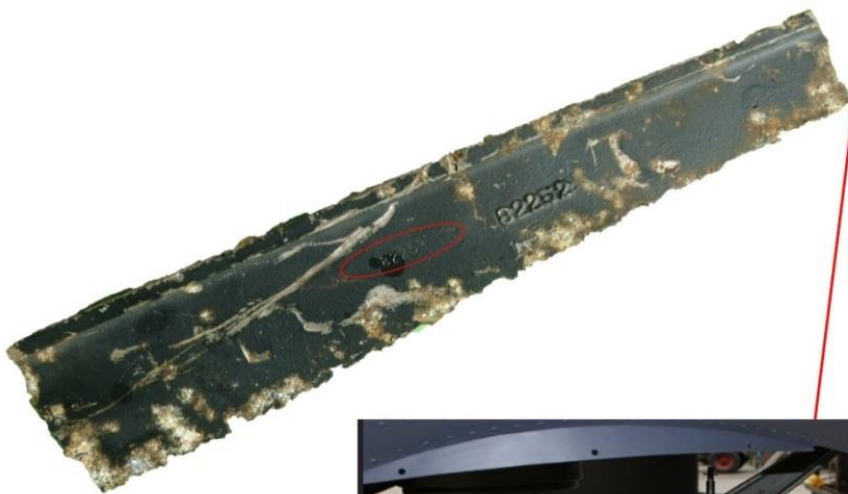
Also found in 2019 was pieces of the chin turret, which belonged on G models, although very few numbers of F planes had them.

Chin Turret Assembly  
Arm hanger Pn# 82253

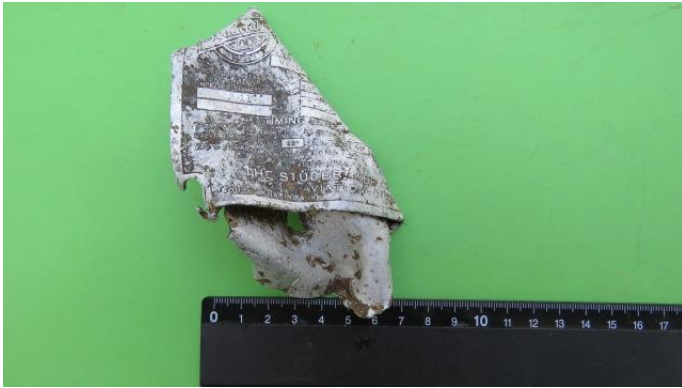
Figure 20-1, Engine data plate, WWIIBRPG

After 100's of hours of searching for 4 months' time, the most important discovery of 2019 was the finding of one of the four engine data plates that would identify an engine by serial number. This serial number is written in the Missing Aircrew Report (MACR). If there is a match, then the aircraft might be identified, there are exceptions, such as an engine swap when an aircraft experienced an engine problem and if the paperwork were not updated, the numbers would not be reflected. Looking for this paperwork was a huge undertaking, and did not prevail, but large credit is due to Marilyn for the effort. This found number did not match the engine numbers in the MACR for 43-38911. The number suffered heavy damage but was managed to be deciphered as best as could on Spangdahlem Air Base at the Non-Destructive Inspection (NDI) center. A luminance bioscopy examination was completed; the number appears to be 43-63662? It also matches some numbers found on a fragment of a crankcase cover, 3-636.. As seen in these pictures.

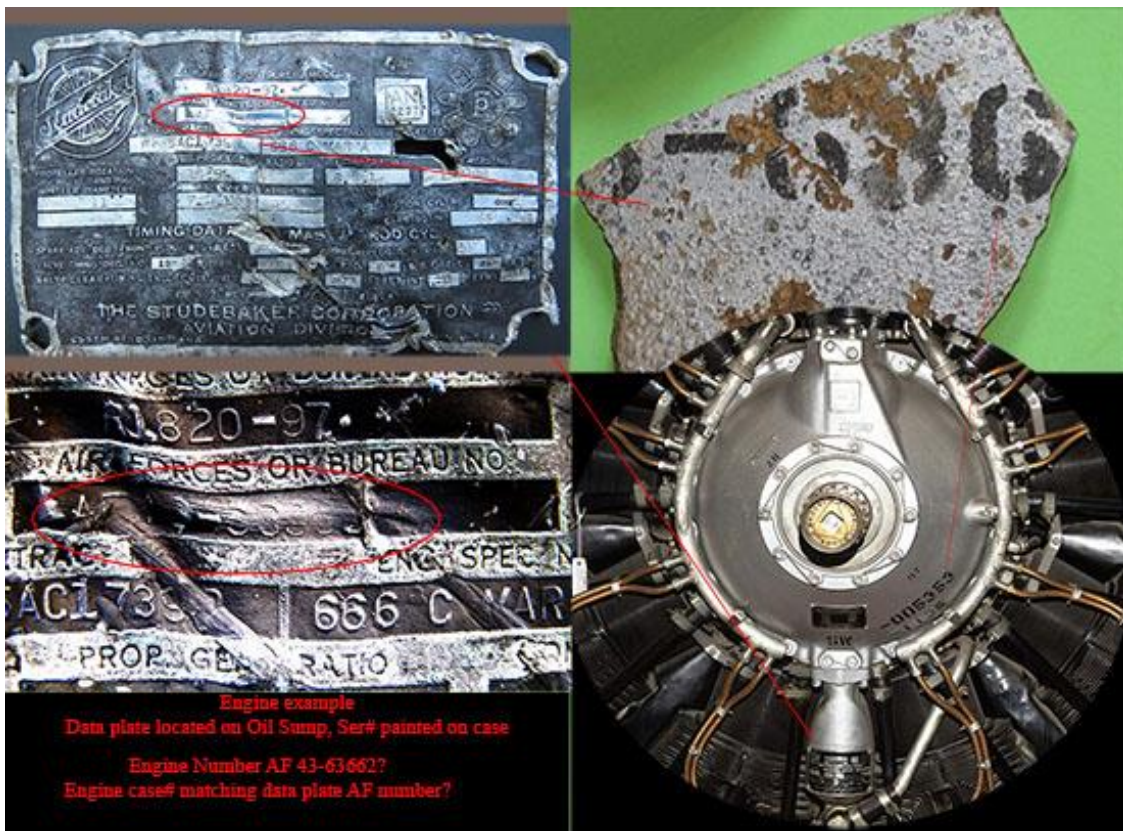
Figure 20-3, Comparison of engine main gear cover and serial # painted, WWIIBRPG, US Air Force Historical Research Agency, AFHRA.

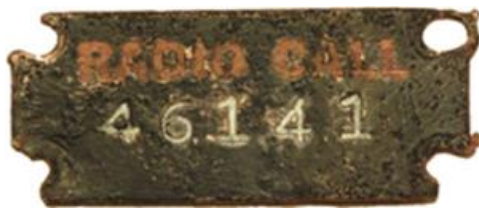
Figure 21-3 Radio Call Plate, WWIIBRPG

The discovery of the radio call plate led to the final definite identification of the plane and thus, the discovery of the mission and what happened to it, as to the crew too. There still has been no MACR or mishap report found on this incident, for reasons not yet known. Although it did not turn out to be the primary aircraft in search of, a 75-year mystery has been resolved and records corrected. The 4 search seasons also engaged a variety of so many helpful and friendly local people of the area from the villages, hunters, forest workers, community leadership the farmers, and motivated small town historians, all of which are grateful to have met and grown to know, and appreciative for their help and understanding. It is also an honor and pleasure to be conversing with family members of the crew of 43-38911, who have given so much assistance. The search for 43-38911, Bull Session is ongoing and recent finds this summer may have led to another discovery that appears to be a good suspect in the mystery.

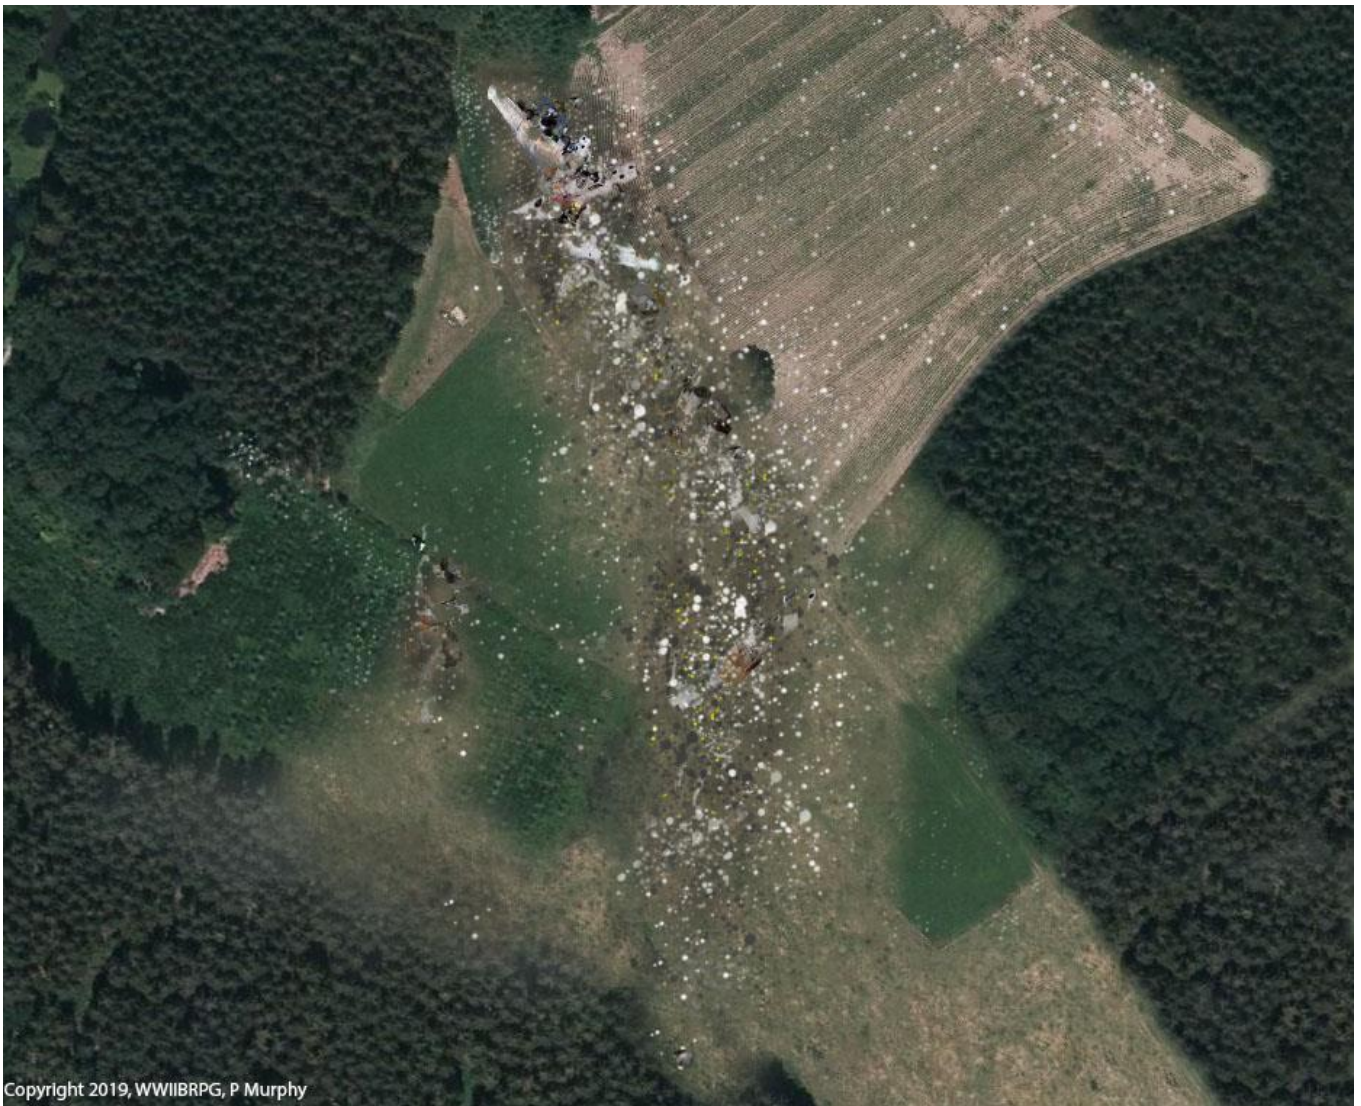
It is also surmised that the small amount of debris found at the top of the field in a small defined area are parts that most likely were left behind or fell from larger pieces when the wreckage was dragged from the lower area to be loaded for transport to the scrap dealer.

Figure 22-1, rendering of the crash scene after hitting the ground. Luxembourg Geoportal, WWIIBRPG,

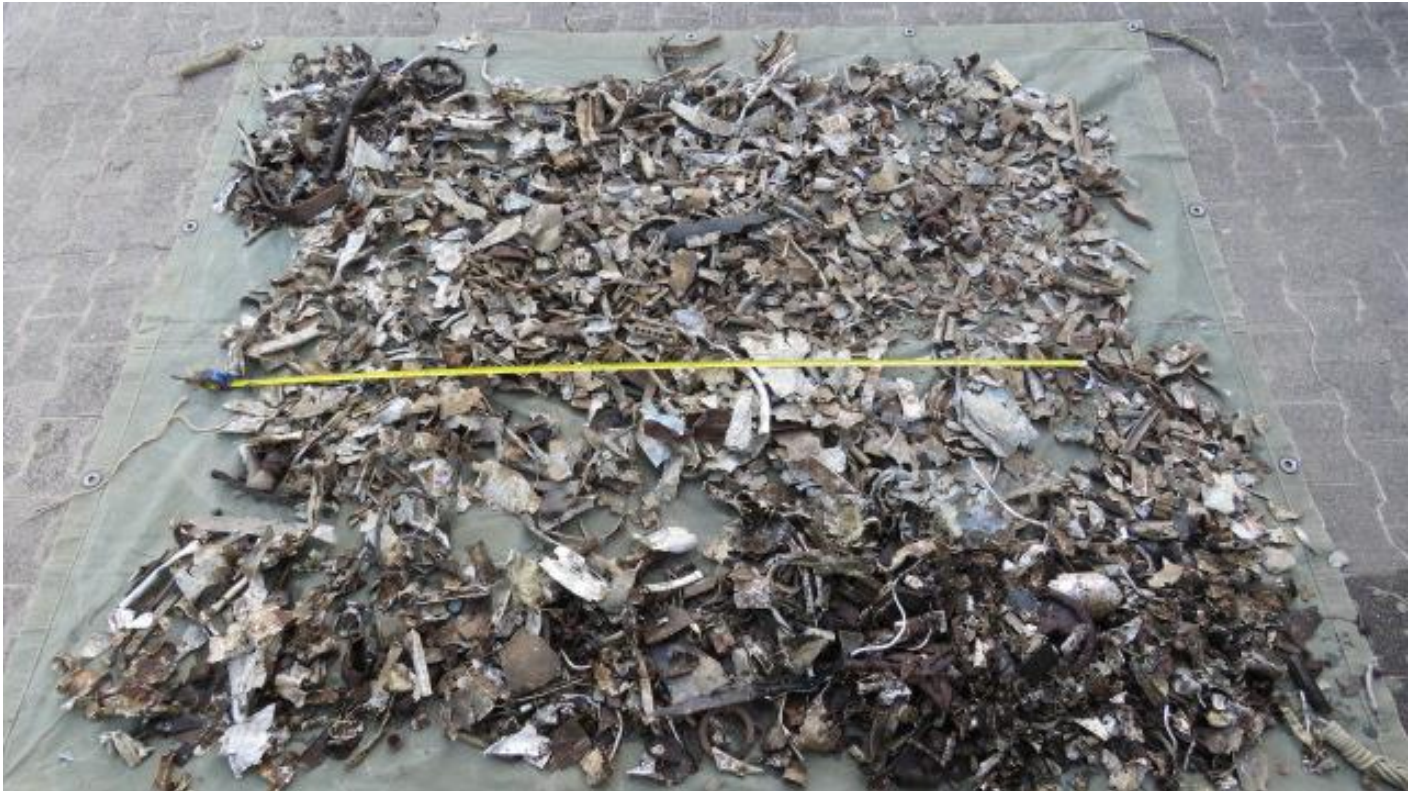
Figure 24-1, 2m tape, Hundreds of thousands of parts from all sections of the aircraft. Each piece picked up one – by -one, a lot of bending down WWIIBRPG

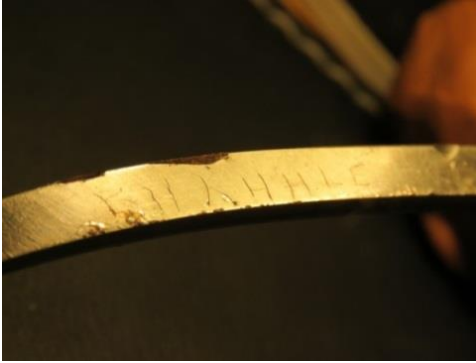
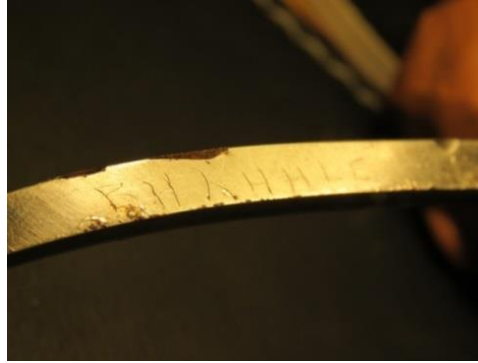
Figure 25-1, Navigator map divider, R H Kahle, WWIIBRPG

Map Divider found in Zone-1, Section 10, Grid-D, name scratched in is R. H Kahle, research ongoing (WWIIBRPG)

Found with the name R H. Kahle. A map divider found Z-1 might belong to one of the following USAAF airmen, with the name on it. List of Richard Kahle:

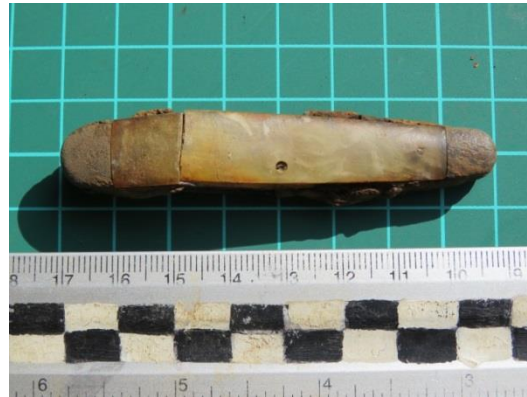
Figure 25-3, pocketknife, Z-1, WWIIBRPG

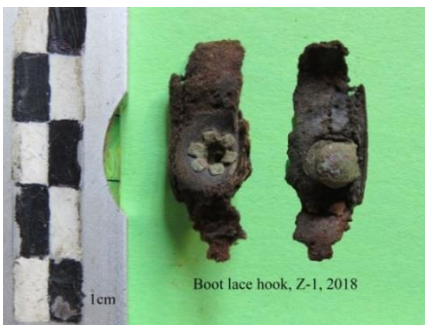
Figure 25-4, Bootlace loop, Z-1, WWIIBRPG

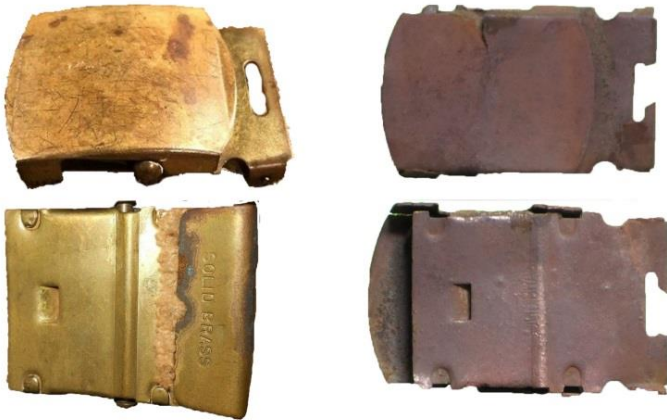
Figure 26-1, US belt buckle, Web, WWIIBRPG

Enlisted mans brass belt buckle  
Z-1, 2018

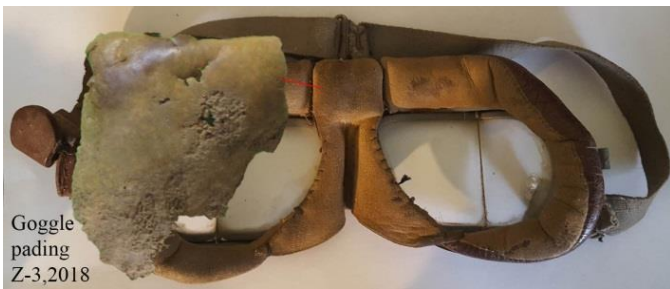
Figure 26-2, Z-3, WWIIBRPG, web

Goggle padding  
Z-3, 2018

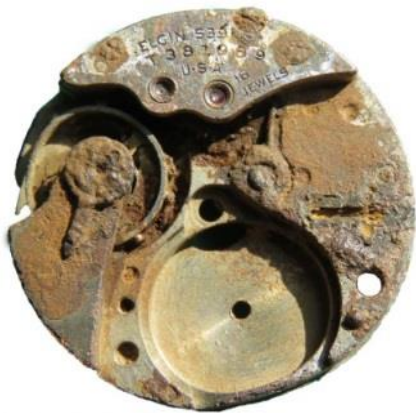
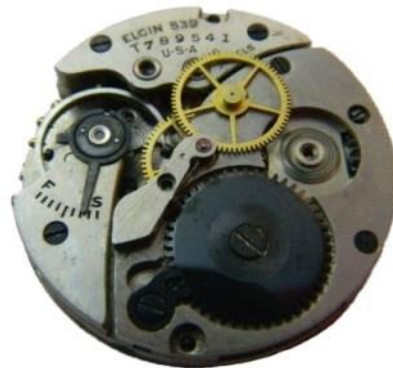
These watches were either issued to officers in the Air Corps or bought privately. The watch would have backing on it that may have given the name and a serial number of the owner. Finding the back would be of significant discovery, as it would identify a crewmember and confirm the aircraft in question. This very important find was discovered in the field Z-1, Grid A-14. The found artifact is on the left compared to a pristine example on the right and below. Figure 26-3, web, WWIIBRPG

Elgin 539 USAAF A-11 watch  
Found Z-1, Grid A-14, 2018  
Produced 1943/44

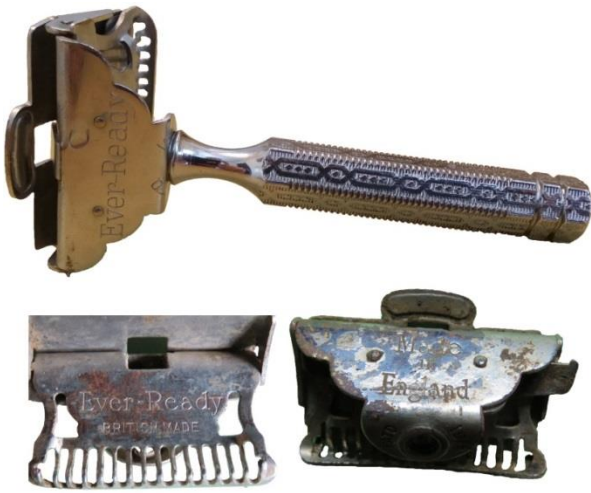
Figure 27-1, Ever-Ready shaving razor, made in England compared to a new one. Web, WWIIBRPG

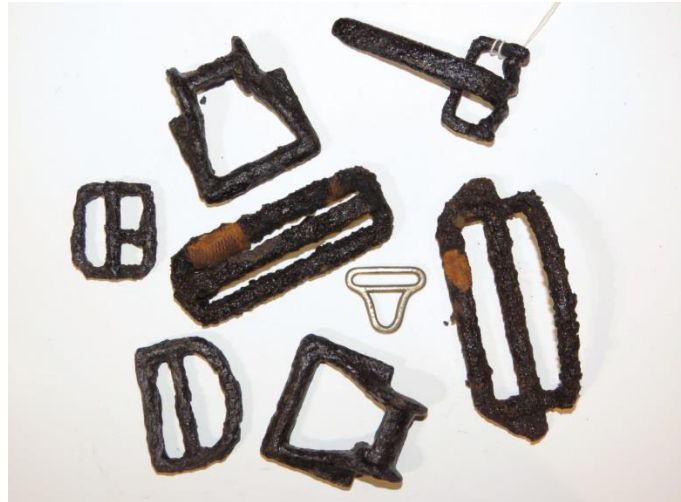
Figure 27-2, a variety of buckles for seat straps, parachute, and clothing. WWIIBRPG

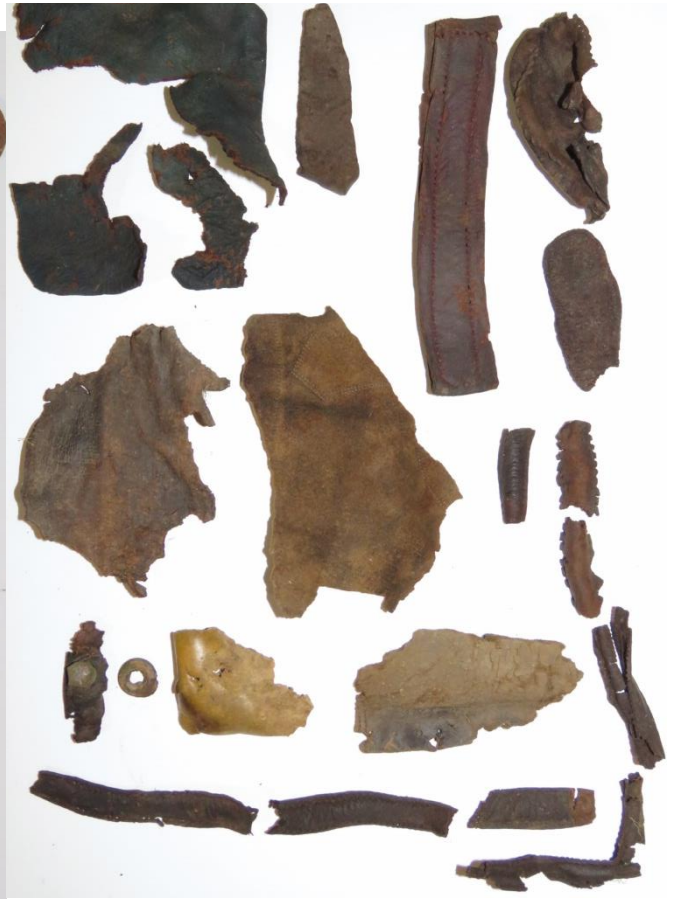
Figure 27-4, leather fragments, WWIIBRPG

Here is an assortment of Flip the Dot snaps, belt, and strap ends. Many of these went to several different types of canvas bags for first aid, flair kits, maintenance bags for tools, and more everyday things on board.

Fragments of leather sometimes found include glove fragments, headgear, shoe, and name tape?

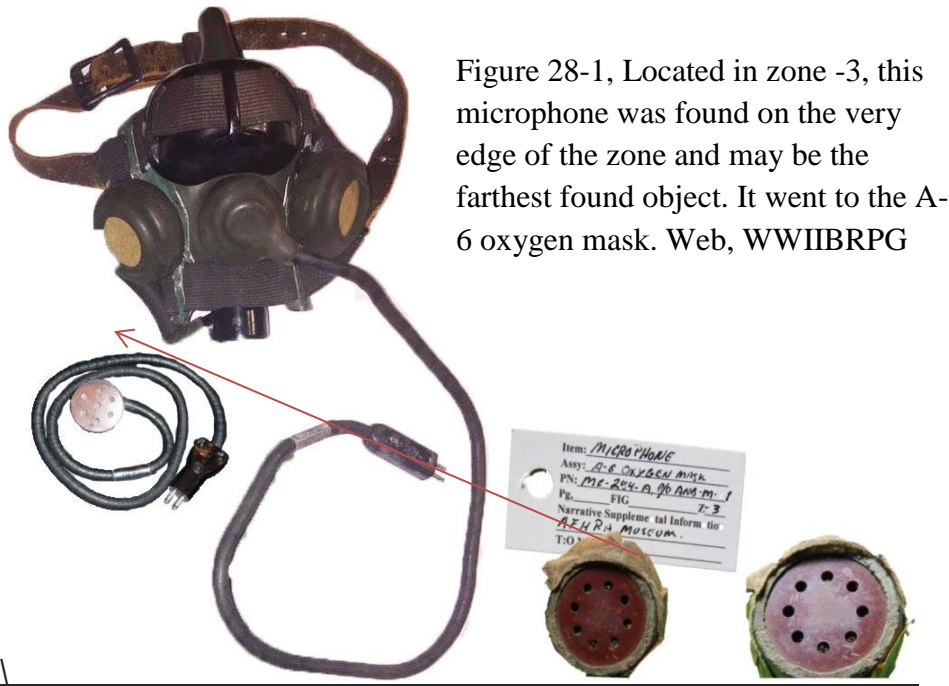
Figure 28-1, Located in zone -3, this microphone was found on the very edge of the zone and may be the farthest found object. It went to the A-6 oxygen mask. Web, WWIIBRPG

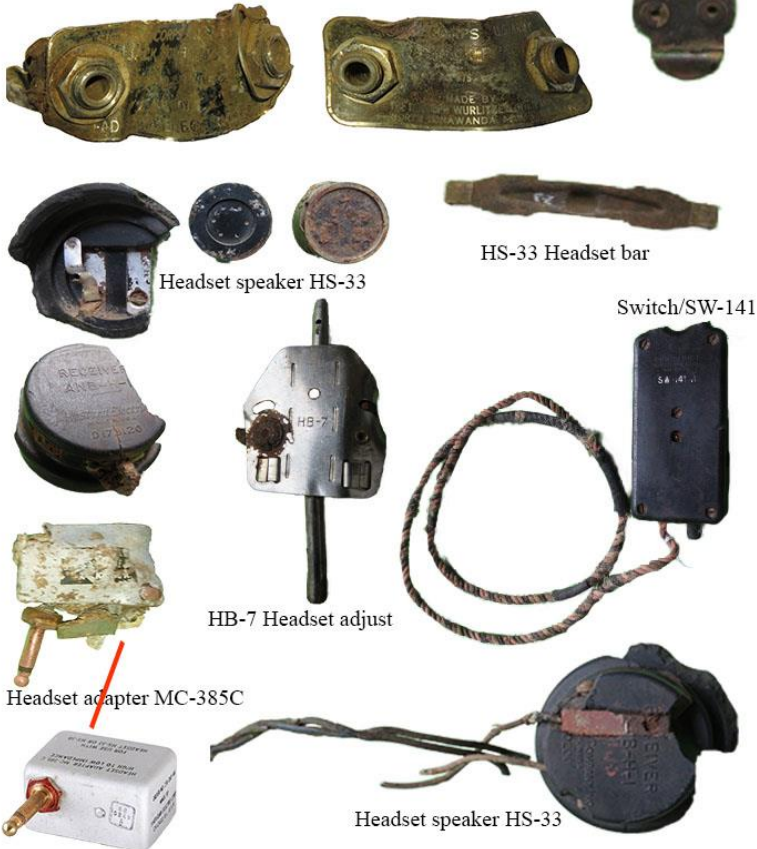
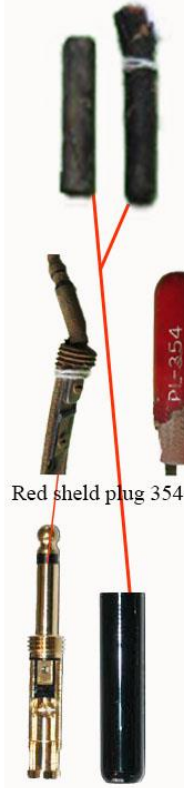
Figure 28-2, AN 01-20EG-4  
Here are some typical intercommunication equipment for all crewmembers, radio operator, pilot, and co-pilot. Crews could talk to each other while jacked into the system. The 354 male plugs coming from the headsets could be configured in several different combinations. Some sets were plugged into the MC-385C Headset Adapter, and sometimes it may have been jacked into the BC-366 Jack Box. Most crewmembers had the SW-141 Switch that hung around the neck, they could unplug and move about the cabin/fuselage and plug into communications BC-366 box along the wall in stations they were working.

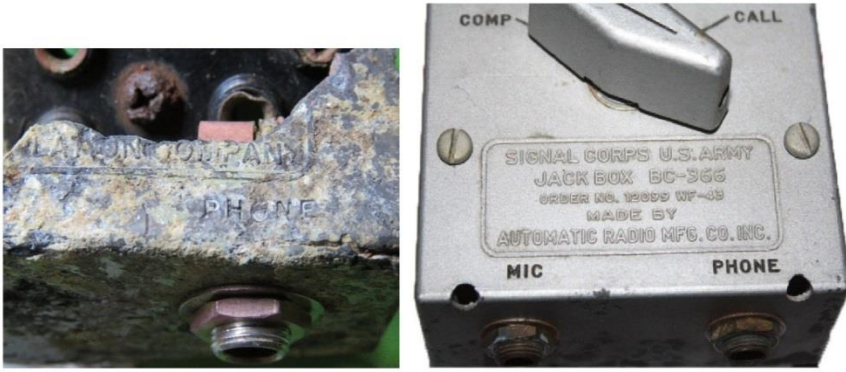
Figure 29-1, on the left, is the remains of a BC-366 Intercom box (Insolation Co.) shown with a well-preserved example. Web, WWIIBRPG

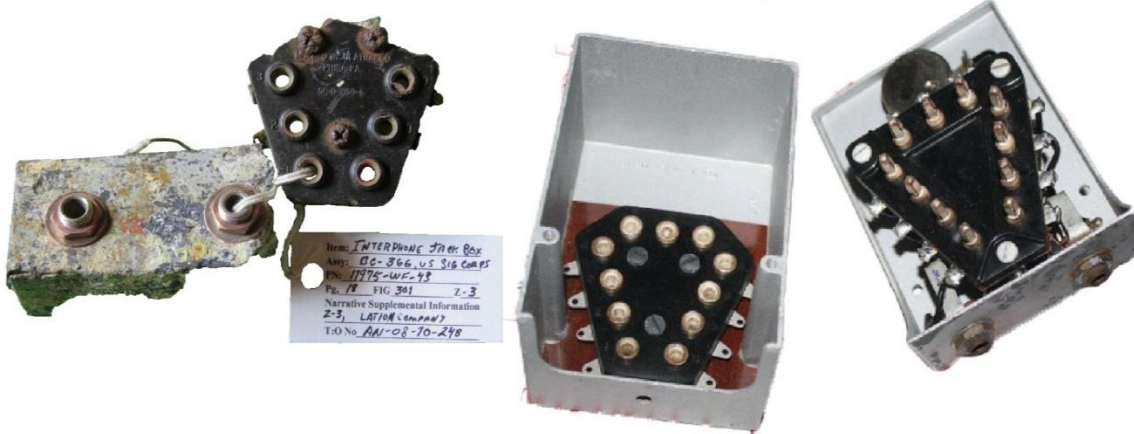
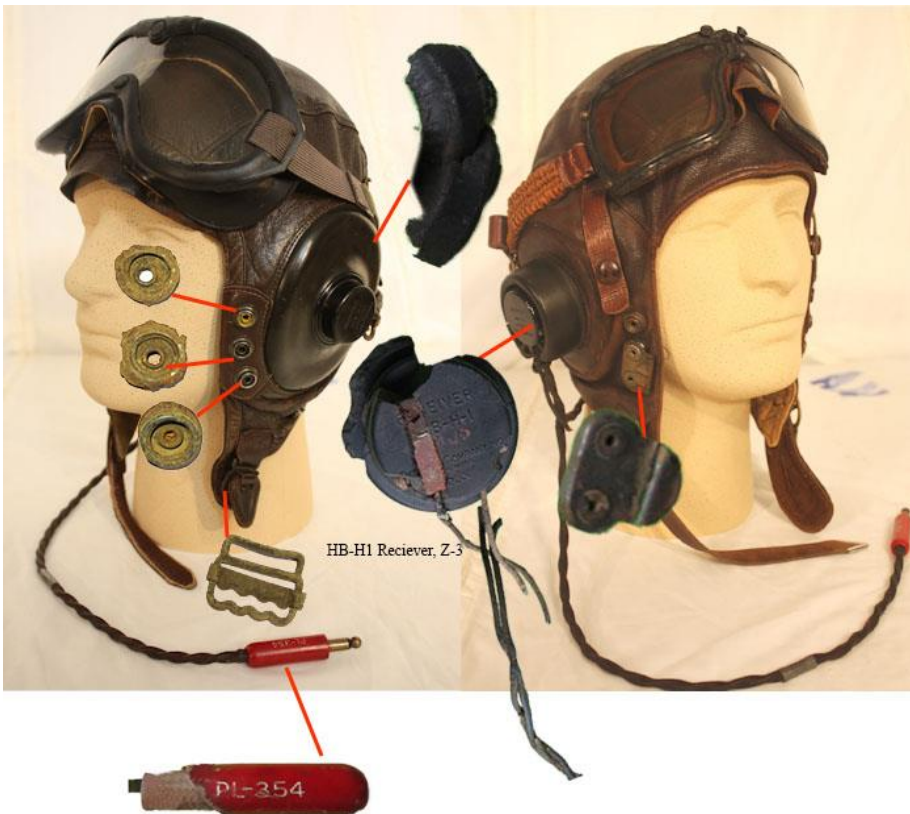
Figure 29-2, some neat and interesting objects found are the pieces and fragments of headsets. They are represented by a couple of different types onboard to include the B-6 flying helmet with built-in speakers, the ANB H1 and HB-7 headset, and adjusters. Pieces of leather and snaps, as well as buckle strap, ends. We can only imagine who wore them and what conversations went through the headsets.

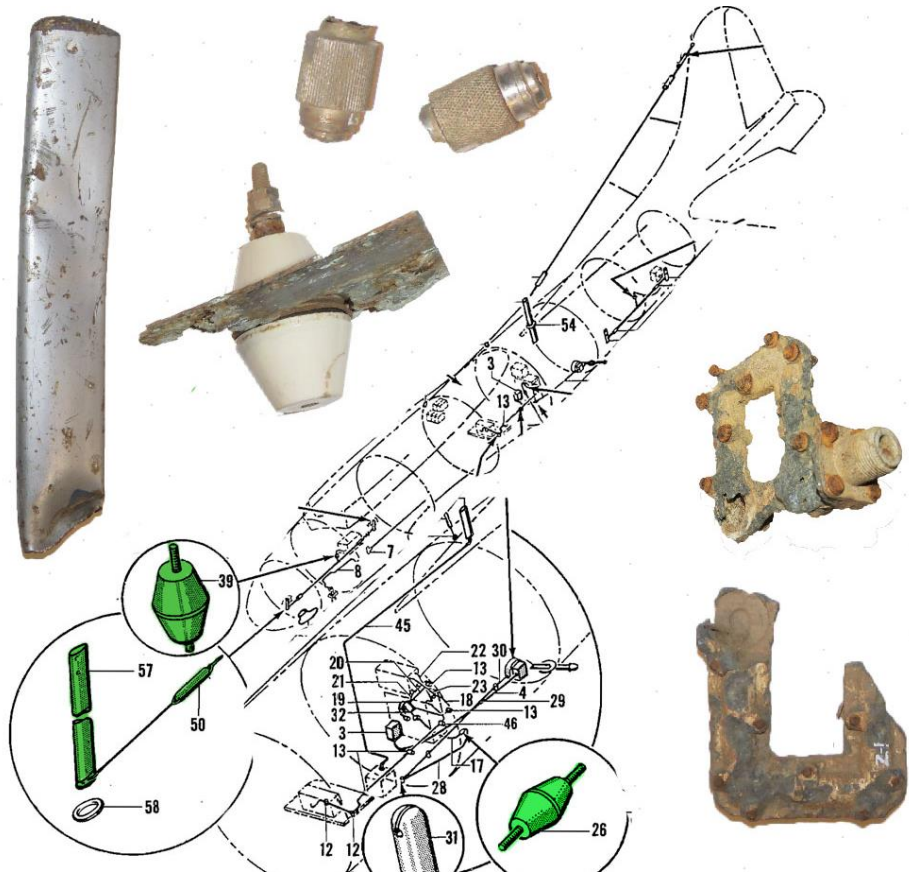
Figure 30-1, antenna assemblies were throughout the ship. Left was an antenna mast, a piece of the original antenna wire was still connected. Also shown is an isolator and two small antenna cable connectors. Right, is a highly sensitive (calibrated) feed horn for probably one of the Navigational inputs, similar to a modern-day satellite connection? WWIIBRPG, AN 01-20EG-4

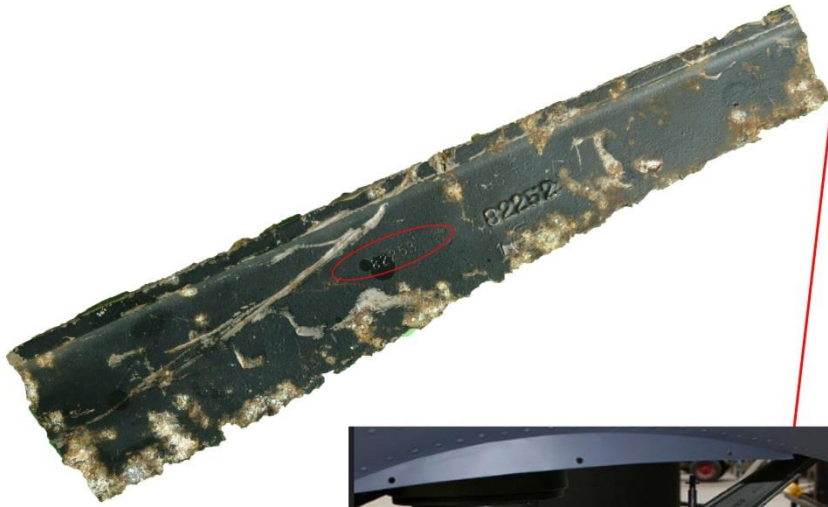
Chin Turret Assembly  
Arm hanger Pn# 82253

Figure 32-1. Here, this brace assembly part found in Z-1, Grid-D, and is located on "G" model aircraft to support the chin turret. web, WWIIBRPG

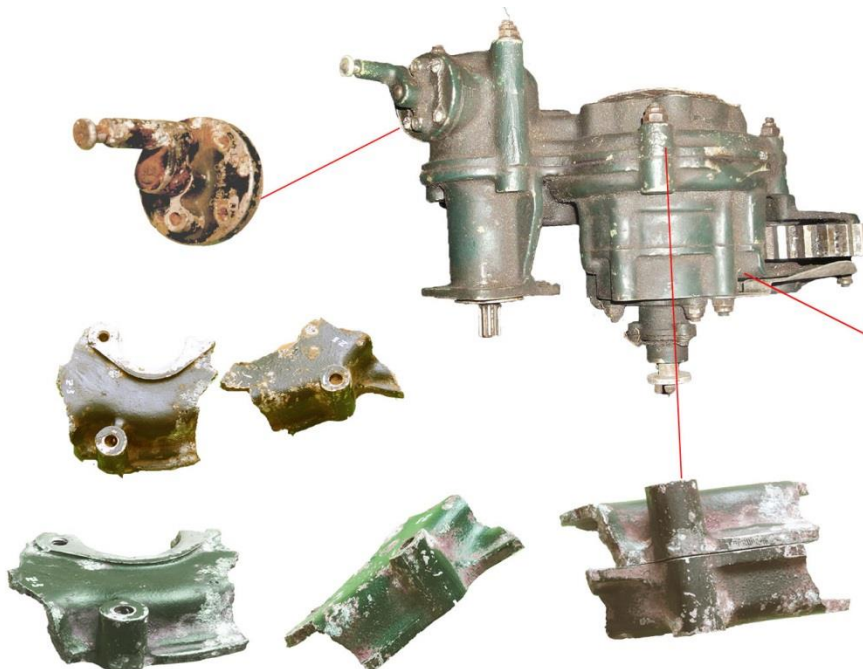
Figure 32-2, Top Turret fragments found in Z-3, Web, WWIIBRPG

Fragments of A1 Top-Turret Azimuth gear assy. Z-3, 2019

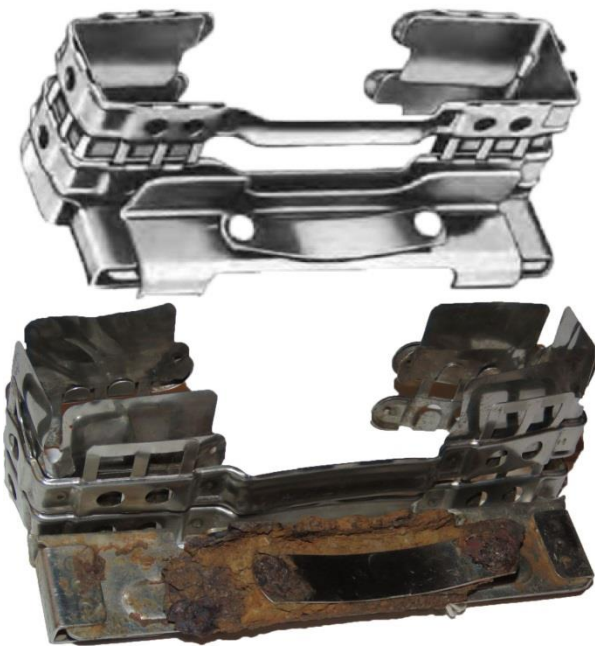
33

The .50 caliber machinegun mount belonged to one of the cheek gun positions in the nose. Also found was the right side of a “chin” gun, the “charging plate”, that would have been in the chin turret, unfortunately, the right side has not been found, the *right side has the serial number of the gun and can be tracked to the aircraft in the paperwork.*

**ADAPTER-GUN END**  
ARMY TYPE L-1

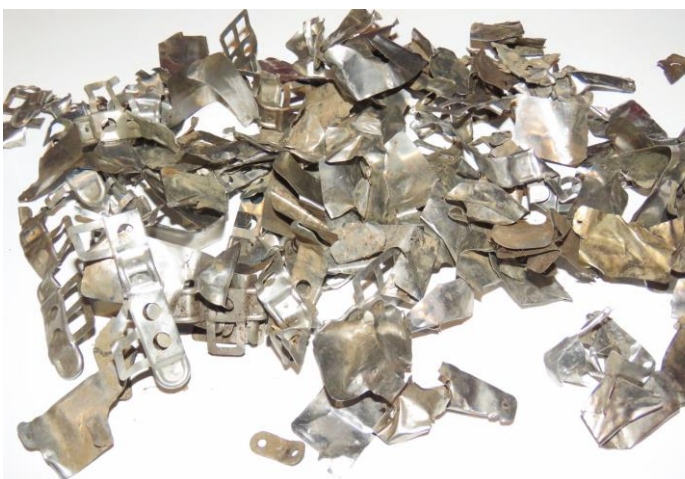
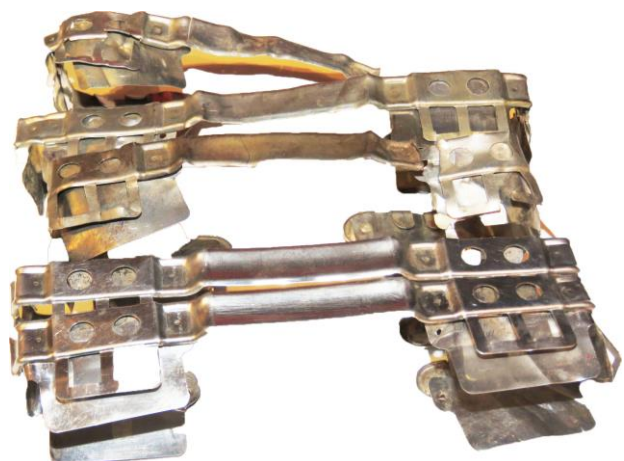
Numerous fragments of Flexible feed chute for the .50s were scattered all over the 4 zones, this style is Lewis-Larson Type-A. Figure 33-3, Army/Navy Weapons, WWIIBRPG

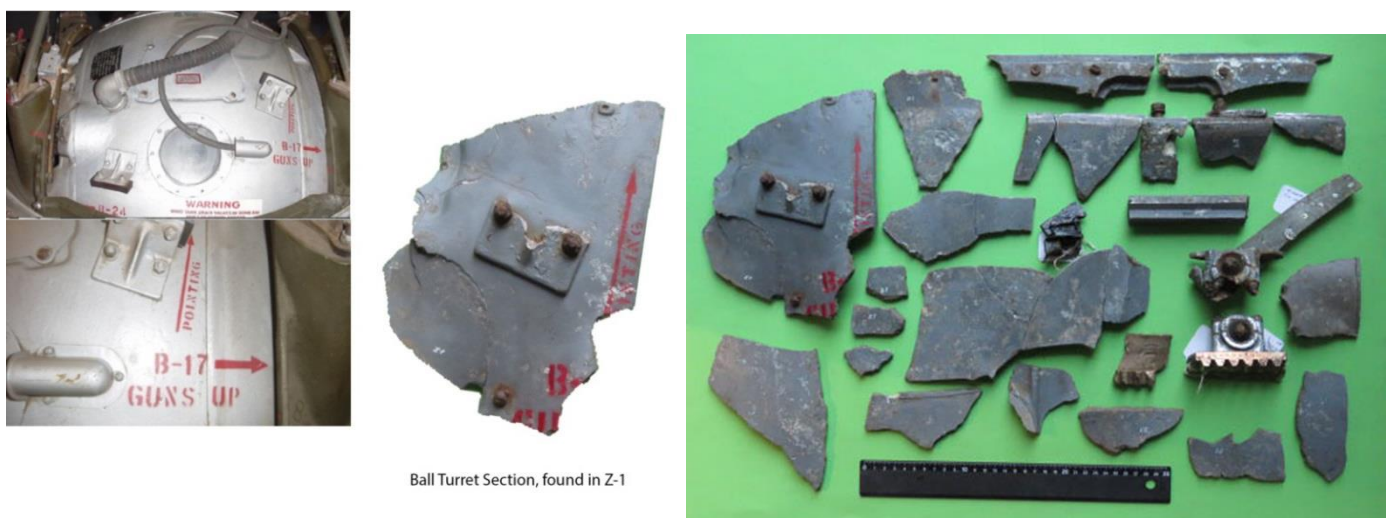
Ball Turret, built by Sperry and the K-4 Automated Gun Sight, components found amongst the debris where the aircraft first connected to the ground and began complete breakup

Ball Turret Section, found in Z-1

Figure 34- 2, Ball Turret Type A-2B or A-13A and fragments found, Web, WWIIBRPG

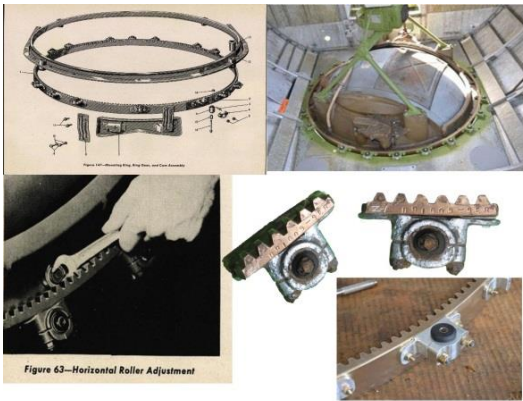
Figure 63—Horizontal Roller Adjustment  
Sperry Ball Turret Azimuth Ring/Gear and Lord Shock, Found Z-1 Sec D-11

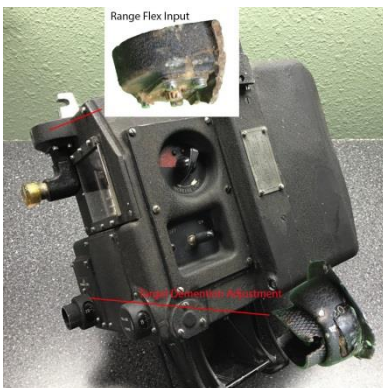
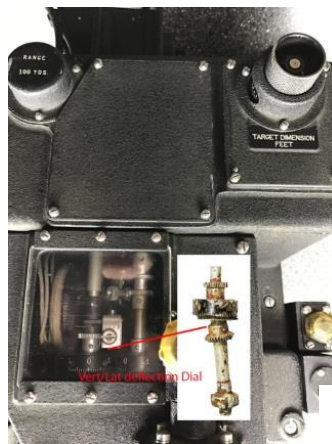
Figure 35-1, web, WWIIBRPG

Figure 35-2, charging handle, Z-1, AN 11-45G-5, web, WWIIBRPG

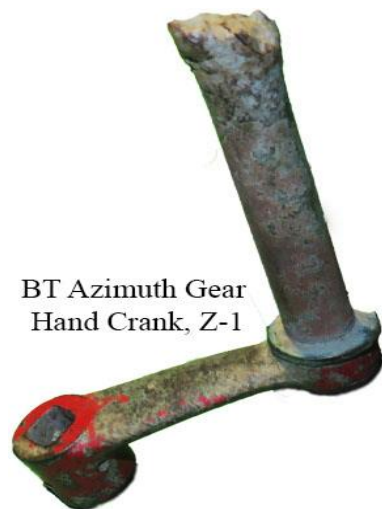
Figure 35-4, WWIIBRPG

BT Azimuth Gear Hand Crank, Z-1

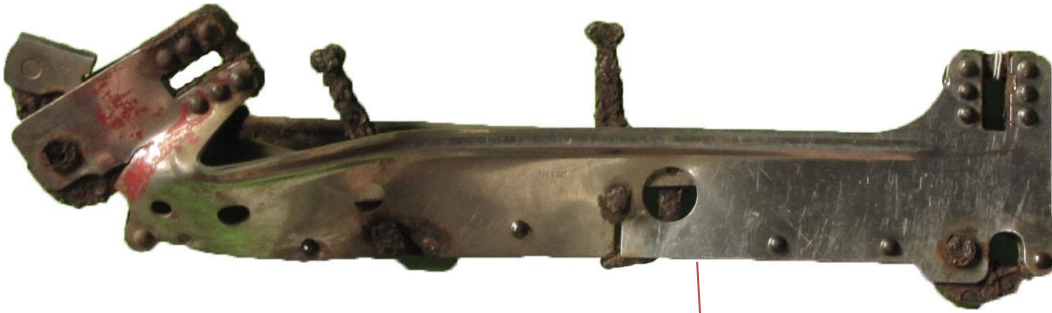
Figure 36-1, Bomb shackle Type B7, 100 – 1100 pound bombs, WWIIBRPG

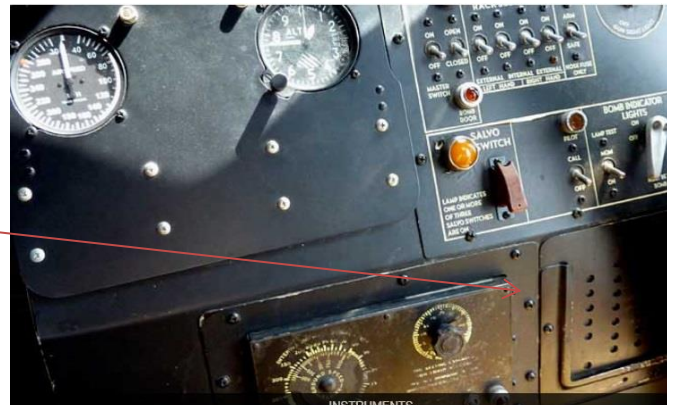
Figure 36-5, Bombardier station with the bomb load indicator. Zone-3. web. WWIIBRPG

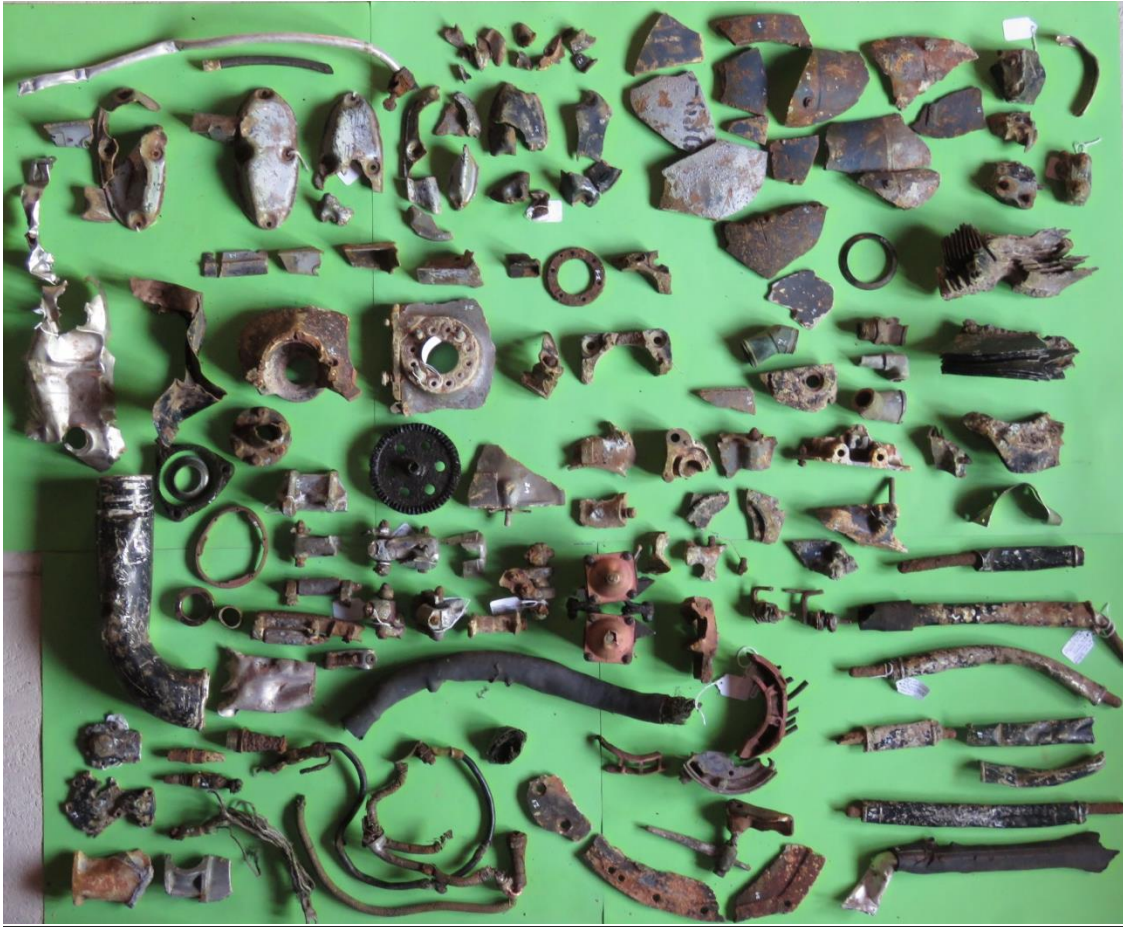
There was a vast amount of engine debris. This shows the better parts found, as there is more, mainly fragments of piston cooling fins and supercharger casing. Items presented here represent ignition wiring, sparkplugs, intake pipe, valve covers, push-rod/covers, oil sumps, impeller fragments, many engine mount bushings, ring mounts, Stromberg carburetor parts, front crankcase cover, heat shroud, cowl mounts, cowl opening rod, piston block a piece of the piston head and more. Figure 37-1
