# WWII BATTLEFIELD RESEARCH AND PRESERVATION GROUP

B-17G crash site concluding findings of Aircraft #44-6141, "Sneakin Deacon"  
United States Army Air Forces, 384th Bomber Group, 544th Bomber Squadron  
Date Found: 14 March 2018. Identified June 2020,  
Northwest of Weicherdange, Luxembourg

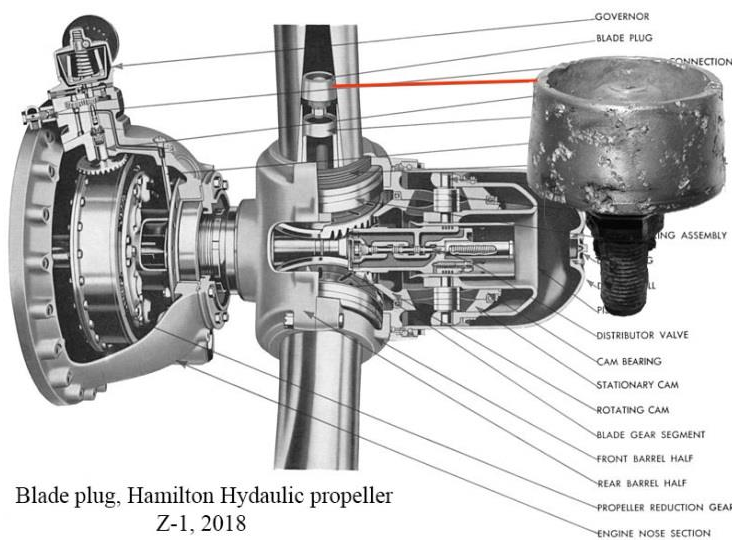
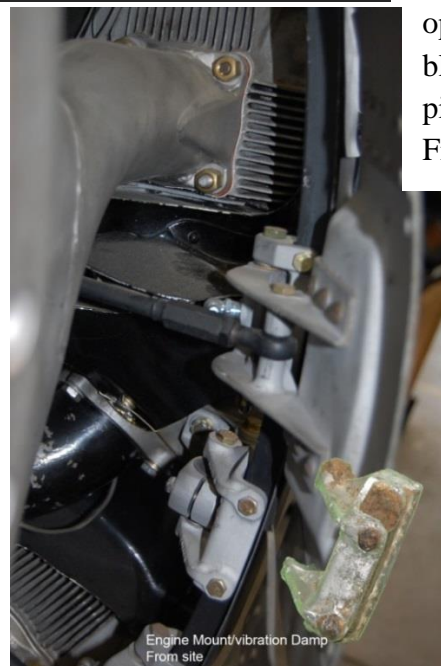
Figure 37-3, Engine mount, web, WWIIBRPG

Figure 37-2, a long-awaited mystery solved. Identified two Blade plugs, made by Hamilton Hydraulic Propeller maker, the plugs are part of the propeller pitch assembly. TO 01-20EF-2, WWIIBRPG Copyright WWIIBRPG, 2020

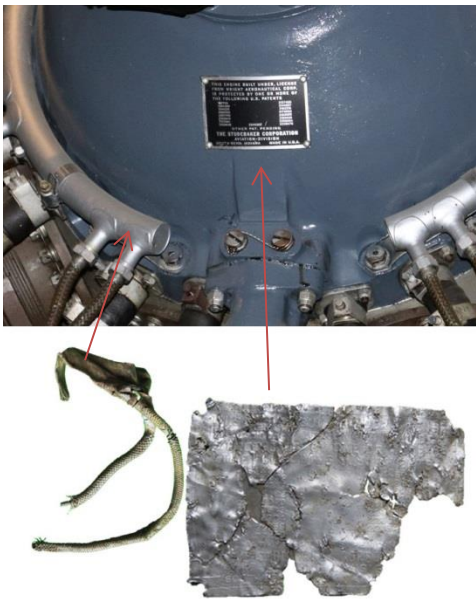
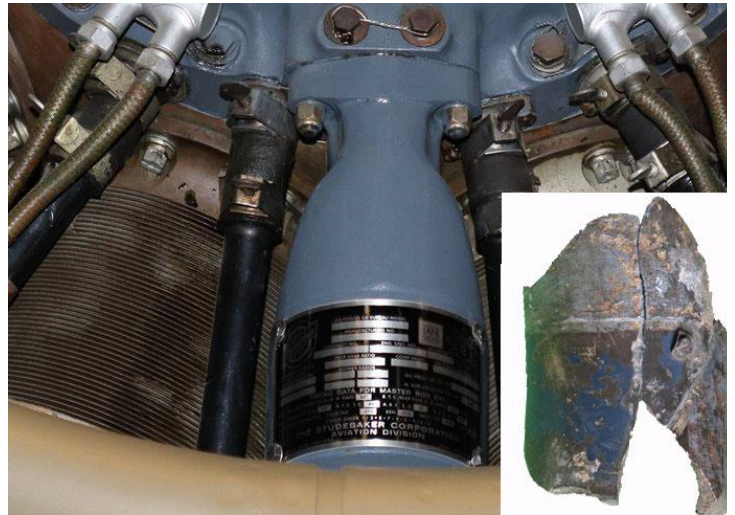
Figure 38-2, Engine oil sump between #5 and #6 cylinders, hot oil used by the engine, is then sent back to be cooled at the oil-cooler. For maintenance purposes, used oil could be purged here. Web, WWIIBRPG

Figure 38-1, The Patent plate listing all patent numbers for the engine, this data plate was found in 3 parts over a 2 month period and put back together, shown here is also shown a part of the ignition wiring harness. On the right is the engine oil sump, where the engine data information plate is and was located on this piece found. This data plate eventually found in 2019, but as mentioned did not match any listed in the MACR for 43-38911. Web, WWIIBRPG

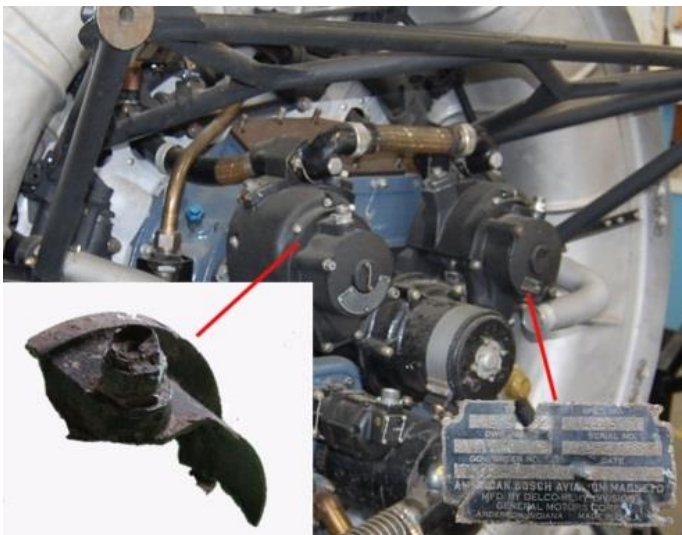
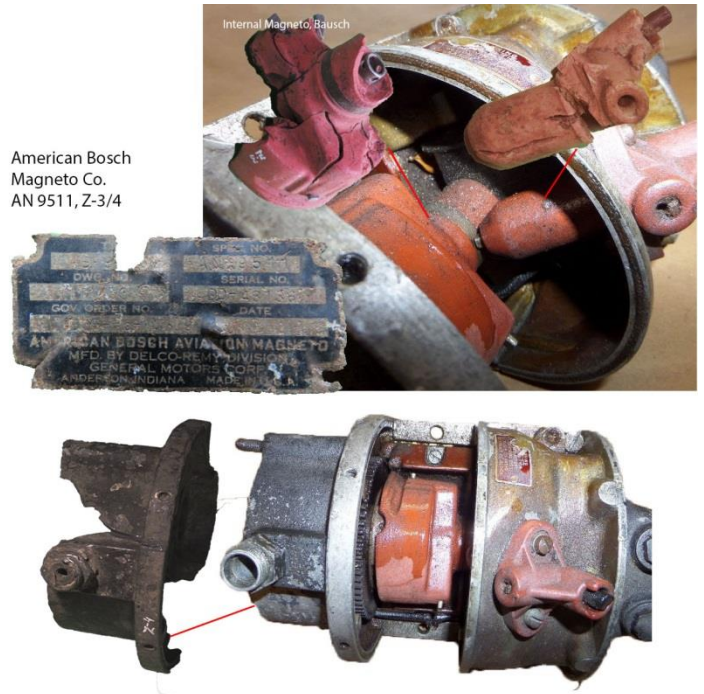
Figure 38- 3-4-5, Components of the engine include pieces of the Magneto, each engine had a left and right. The left magneto controls the firing of the rear spark plugs and the right controlling the front plugs. Web, WWIIBRPG

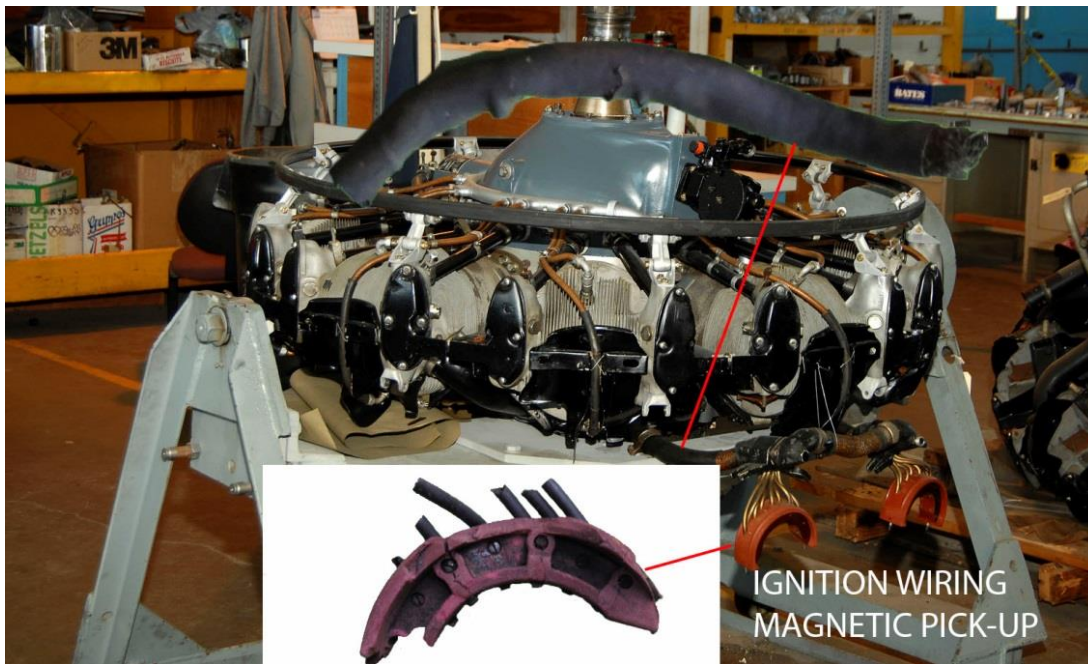
Figure 39-1, web, WWIIBRPG

Figure 39-2, The Cuno oil filter screen, seen here is the cover for the filter. The data plate that was on the cover also provided guidance to changing out the filter screen, one has to wonder about the force it takes, to rip this plate away from the bolts with no damage, even as they were safety wired. B-17 Maintenance Engine Manual,

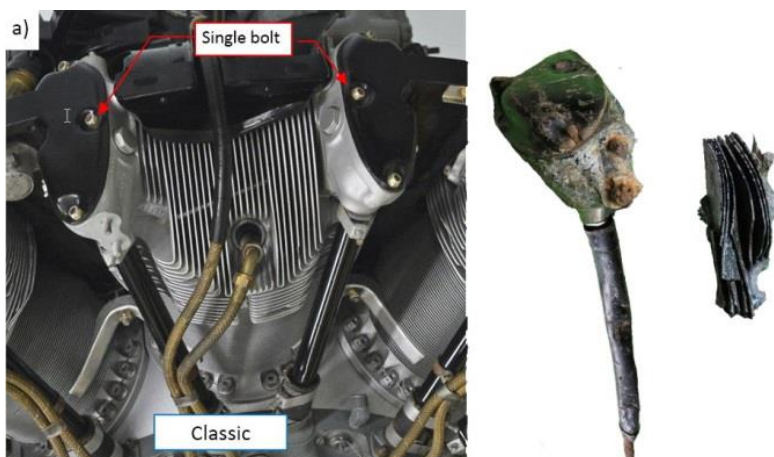
Figure 39-3, A composite of an engine part (right) to show where components articulate. A small example of one of the valve box with a cover connected to a push rod and a fragment of the center cooling fins. web, WWIIBRPG

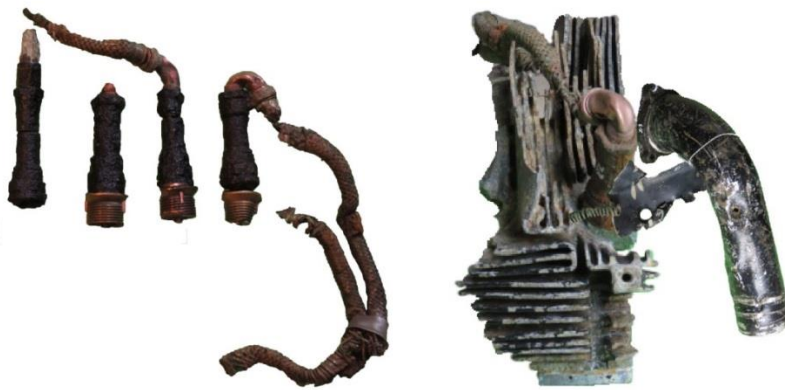
Figure 40-1 showing several sparkplugs that were found along with ignition wiring. WWIIBRPG

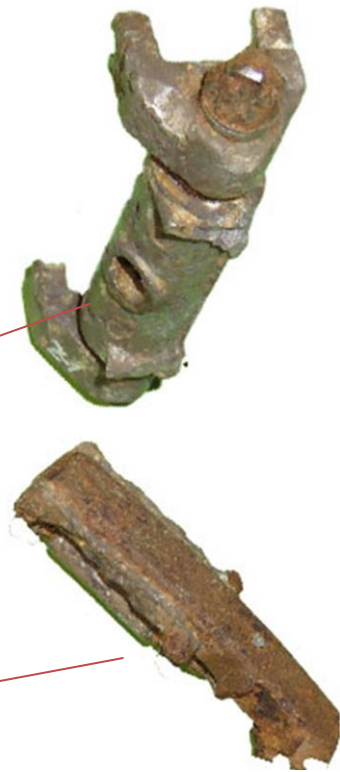
Figure 40-3, The cowl hinge assembly, the levers control the cowl flaps for opening or closing allowing cooler air in or keep it out, keeping the engine temperature stable during different altitudes. AN 01-20EG-4

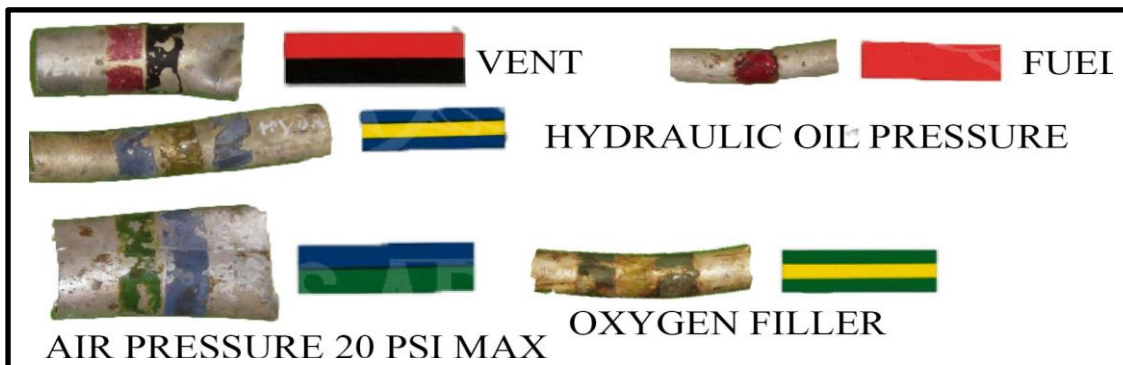
Figure 40-4, Miles of aluminum lines found throughout the plane, all have color-coding for maintenance to quickly chase down issues, and there are 24 different color schemes. Web, WWIIBRPG

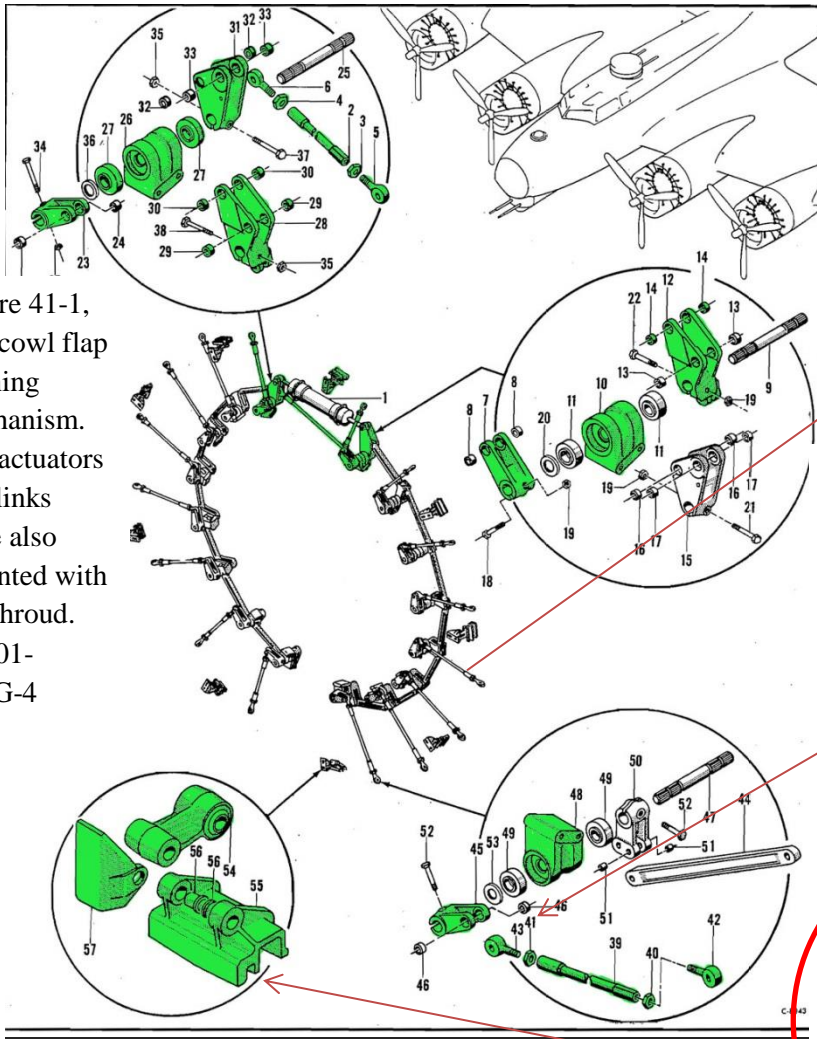
Figure 41-1,  
The cowl flap  
opening  
mechanism.  
The actuators  
and links  
were also  
mounted with  
the shroud.  
AN 01-  
20EG-4

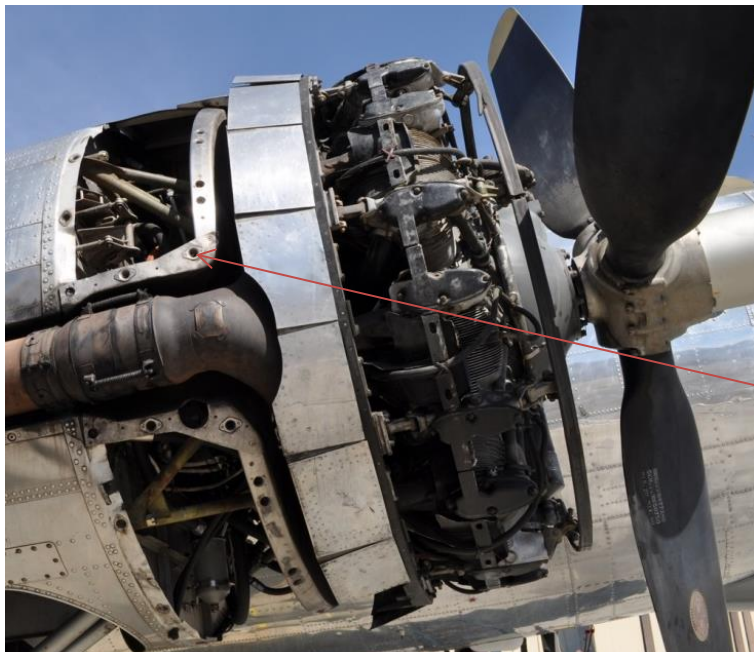
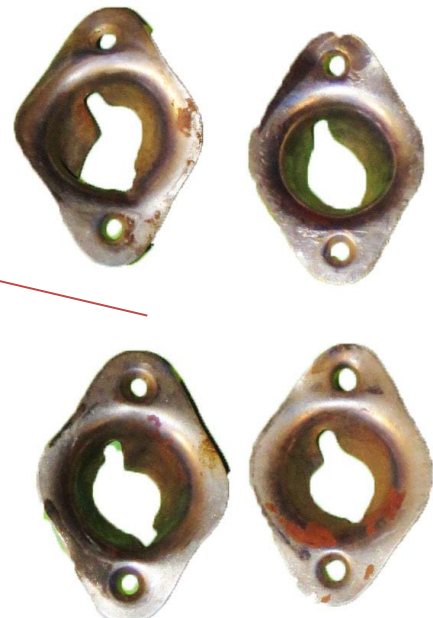
Figure 41-4,  
Found were  
more than a  
dozen of  
these quick  
fasteners for  
closing the  
segment  
cowl covers.  
On the left  
photo, the  
covers are  
off, web,  
WWIIBRPG

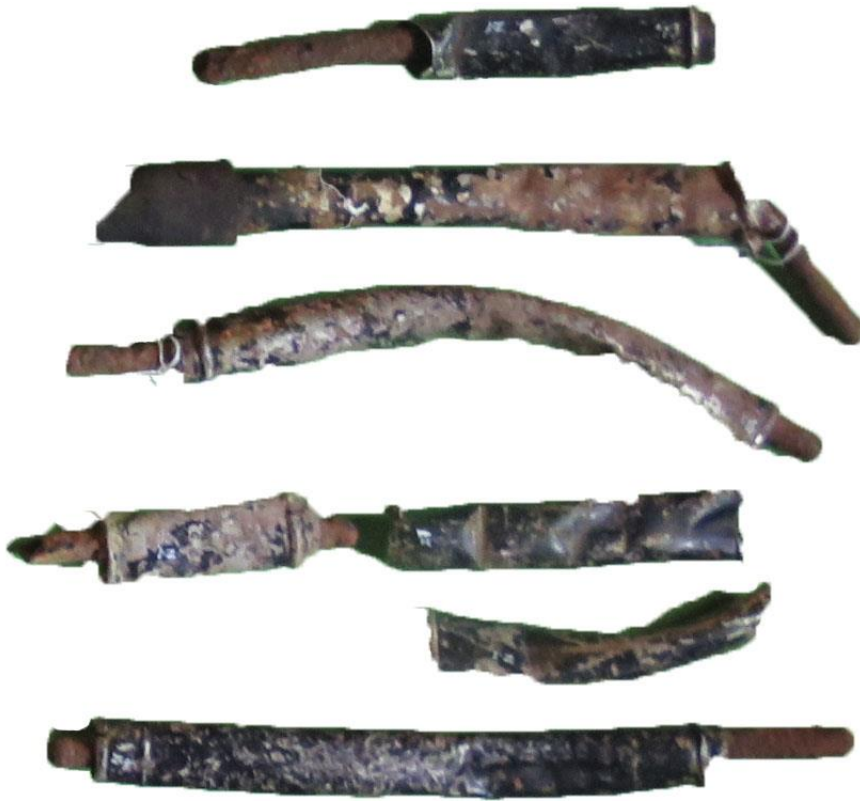
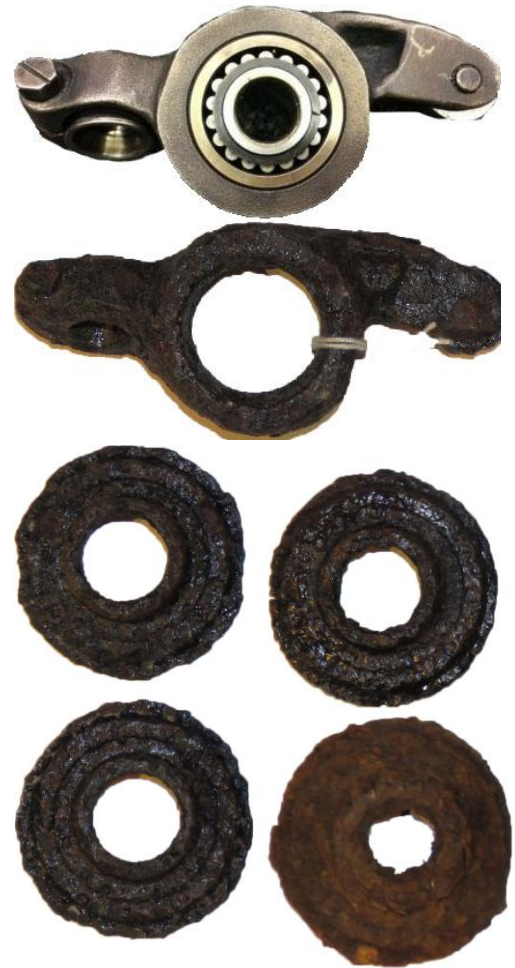
Figure 42-1, Push rods and covers above, to the left are valve rocker box covers, broken off are the extended wings that were on this version. Web, WWIIBRPG

Figure 42-2, Internal engine parts found, here are some upper valve spring washers (PN 69271) and the Exhaust Rocker Arm (PN B9609), the latter compared to a new rocker

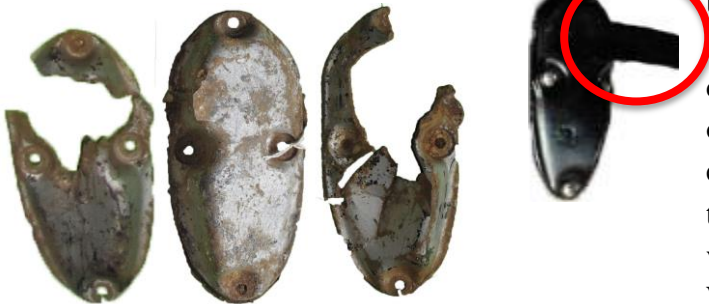
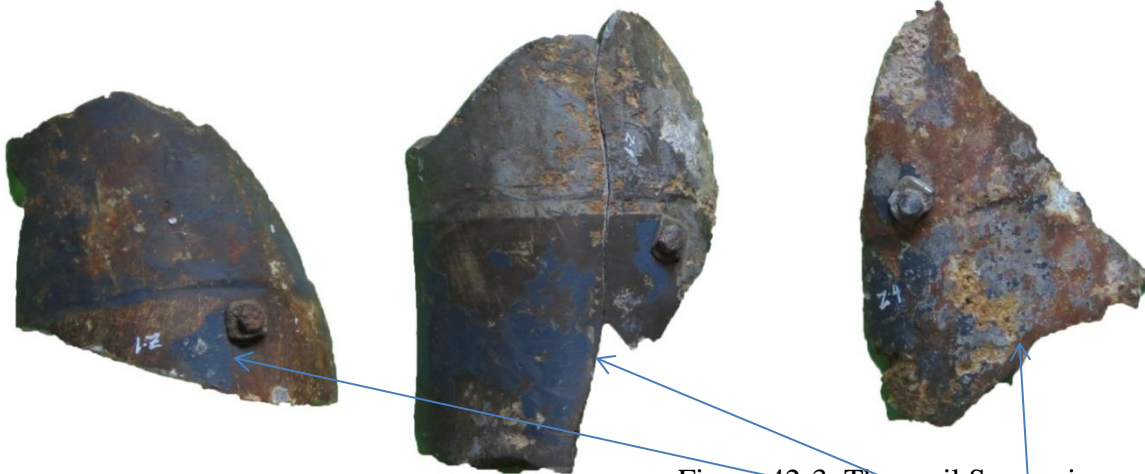
Figure 42-3, Three oil Sump pieces. This represents three different engines. Here in the squared area of the blue field is where the engine data plate attached. The complete sump is seen in Fig 39-2. WWIIBRPG

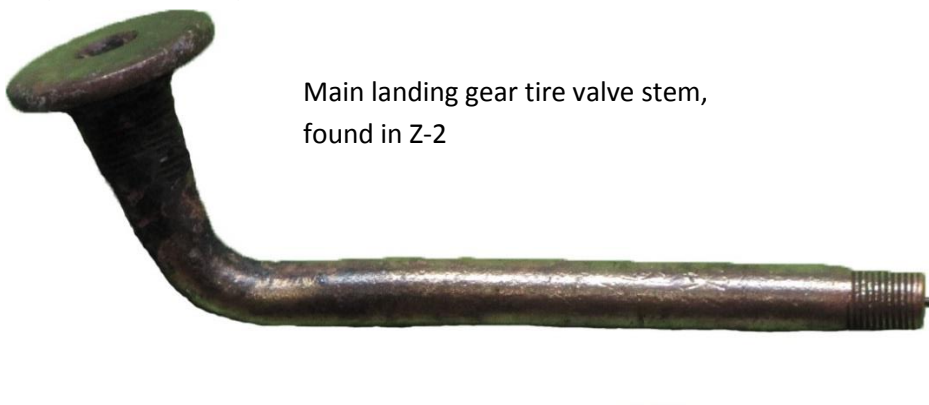
Main landing gear tire valve stem, found in Z-2

Figure 43-2, The Schrader made valve stem.  
 from Wikipedia: The **Schrader valve** (also called the **American valve**) is a type of pneumatic tire valve used on virtually every motor vehicle in the world today. The Schrader company, for which it was named, was founded in 1844 by August Schrader. The original Schrader valve design was invented in 1891 and patented in the United States in 1893. WWIIBRPG

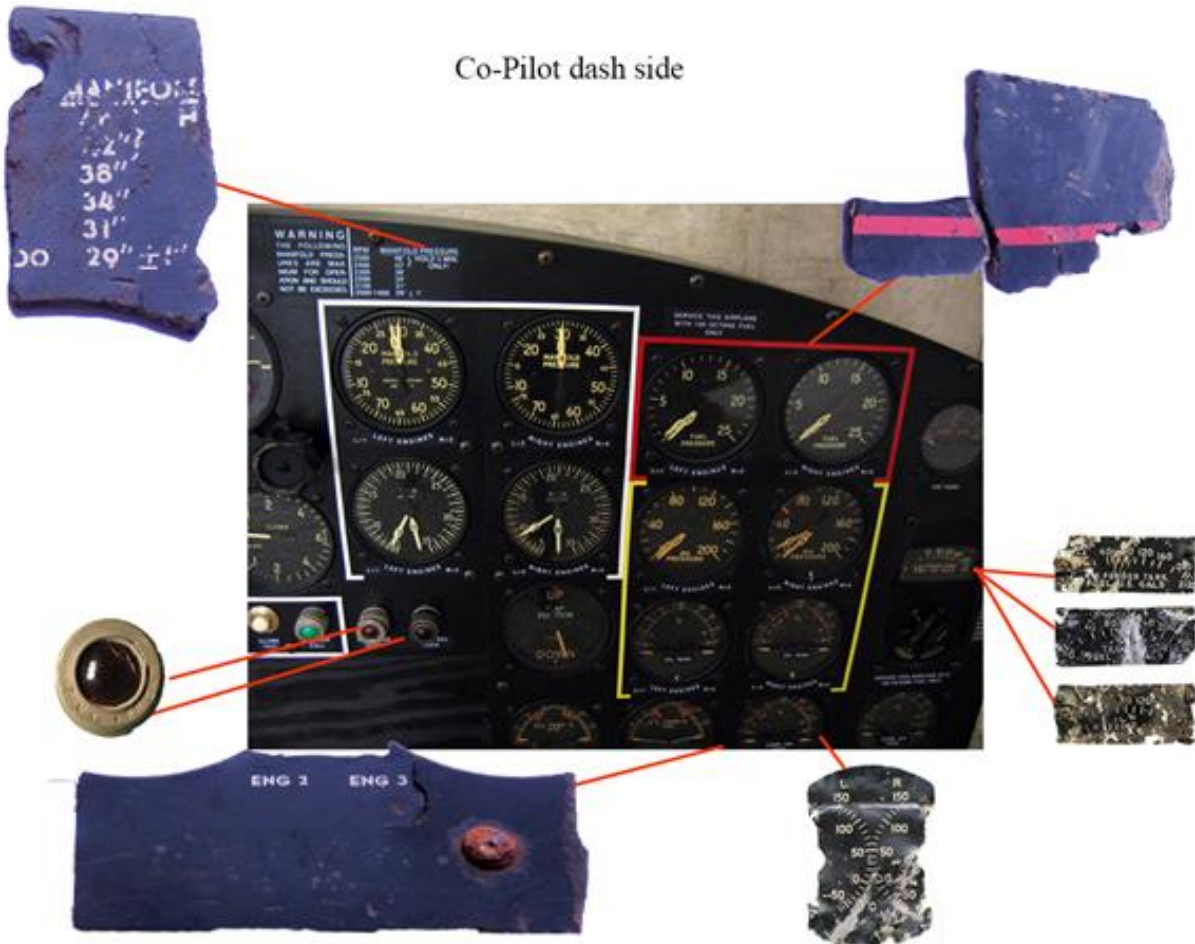
Figure 44-4, Co-pilot side of dash indicators, pieces found in Z-1, 3, web, WWIIBRPG

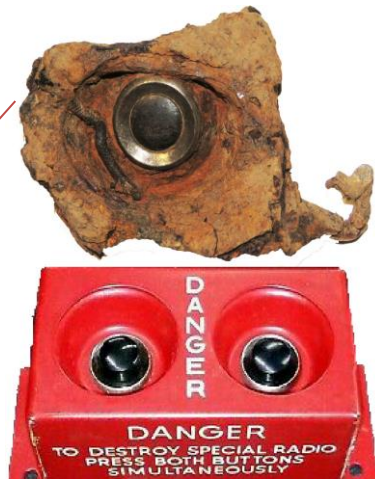
Figure 45-2, The BC-765 Switch Box is part of the SCR-595 Identification Friend or Foe (IFF) radio systems. In the event of potential capture of the aircraft by the enemy, the crew was to destroy the IFF system. Web,

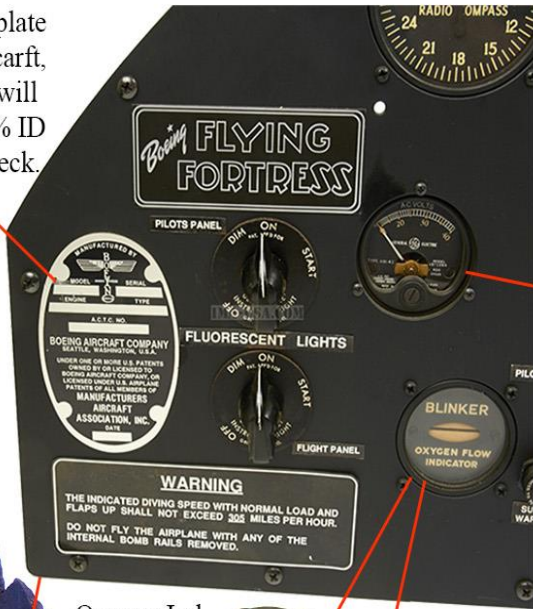
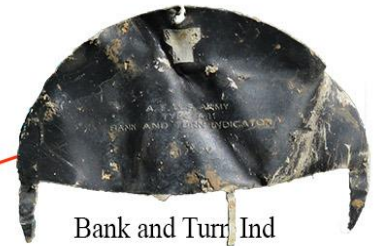
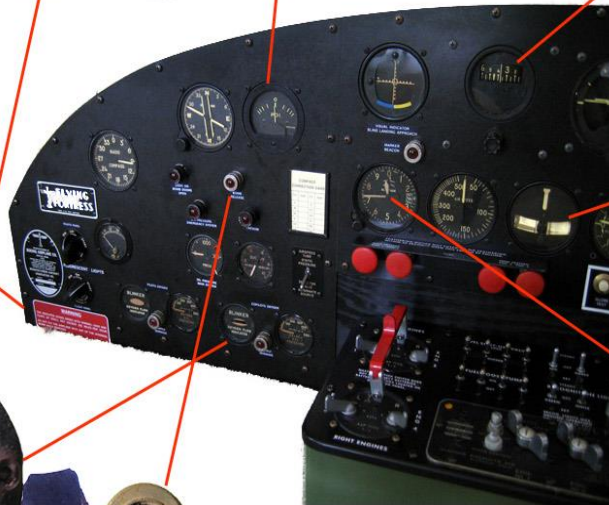
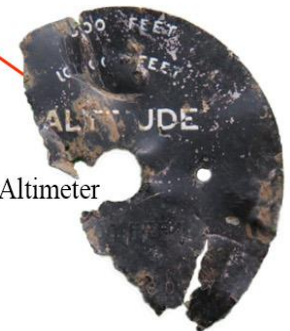
Figure 46-1, A fragment of the pilot side dash was found, but the data plate was not there, only the screw that held it. Web, WWIIBRPG

The data plate of the aircraft, if found will give 100% ID of the wreck.

Voltage meter

Gyro Directional Ind

Oxygen Ind  
Blinker

Bank and Turn Ind

Altimeter

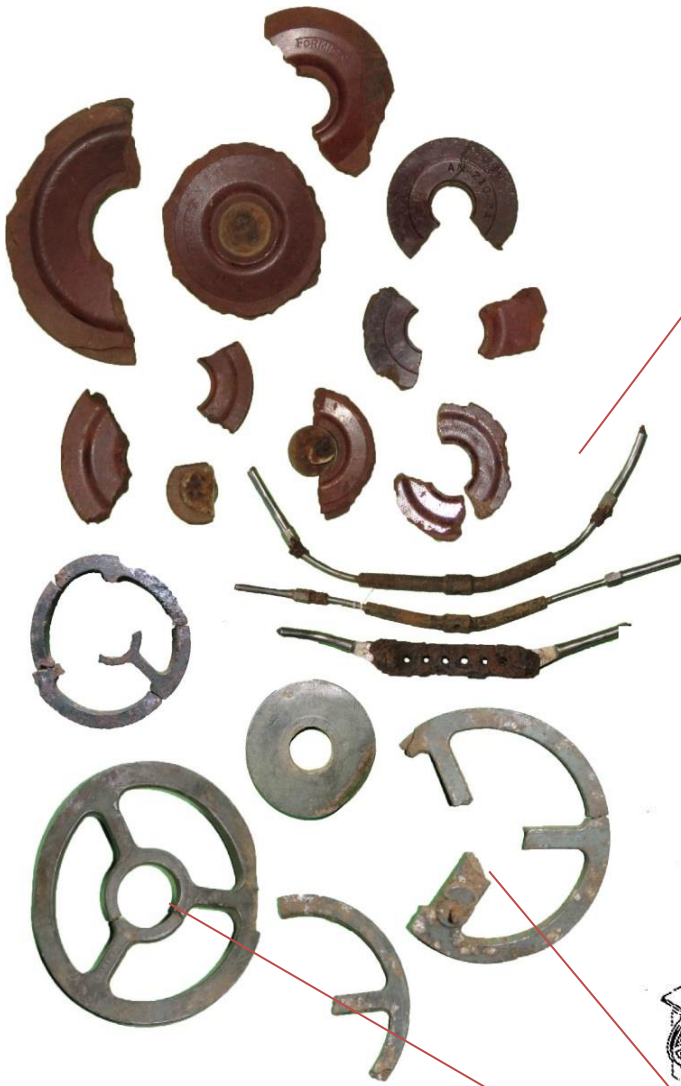
Figure 49-2, control cables, web

Figure 49-1, Throttle and Trim Tab controls, located in the center control stand, between the Pilot and Co-pilot. The pulleys here differ from the cable pulleys above and are made of aluminum instead of pressed Formica board. Also shown are a few cable connection joints, as shown in figure 49-2. WWIIBRPG, AN 01-20EG-4, web

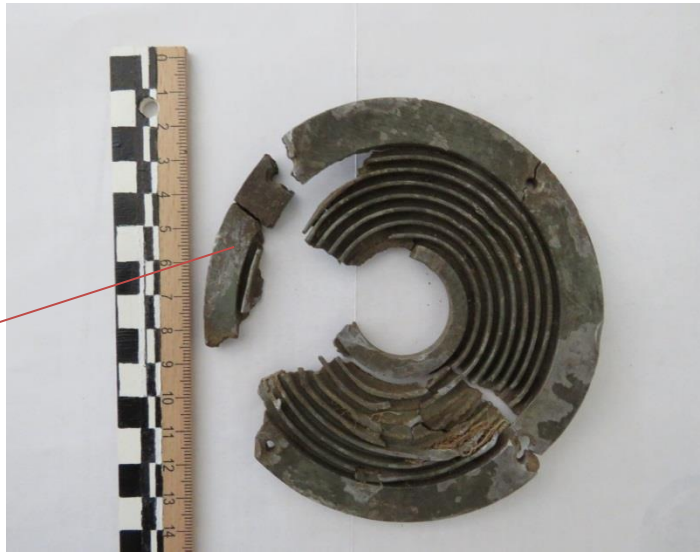
Figure 50-2, WWIIBRPG

Figure 50-1, Rudder trim tab, found in Z-3, grid 13-L, AN 01-20EG-4, WWIIBRPG

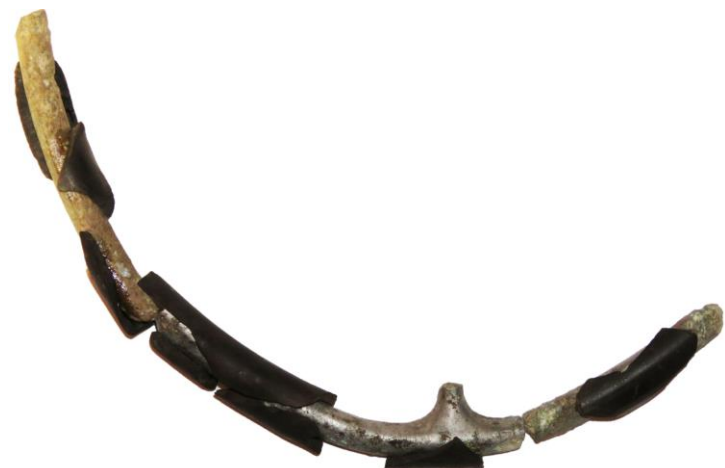
Figure 50-5, Fragments of the Yoke "steering", WWIIBPRG

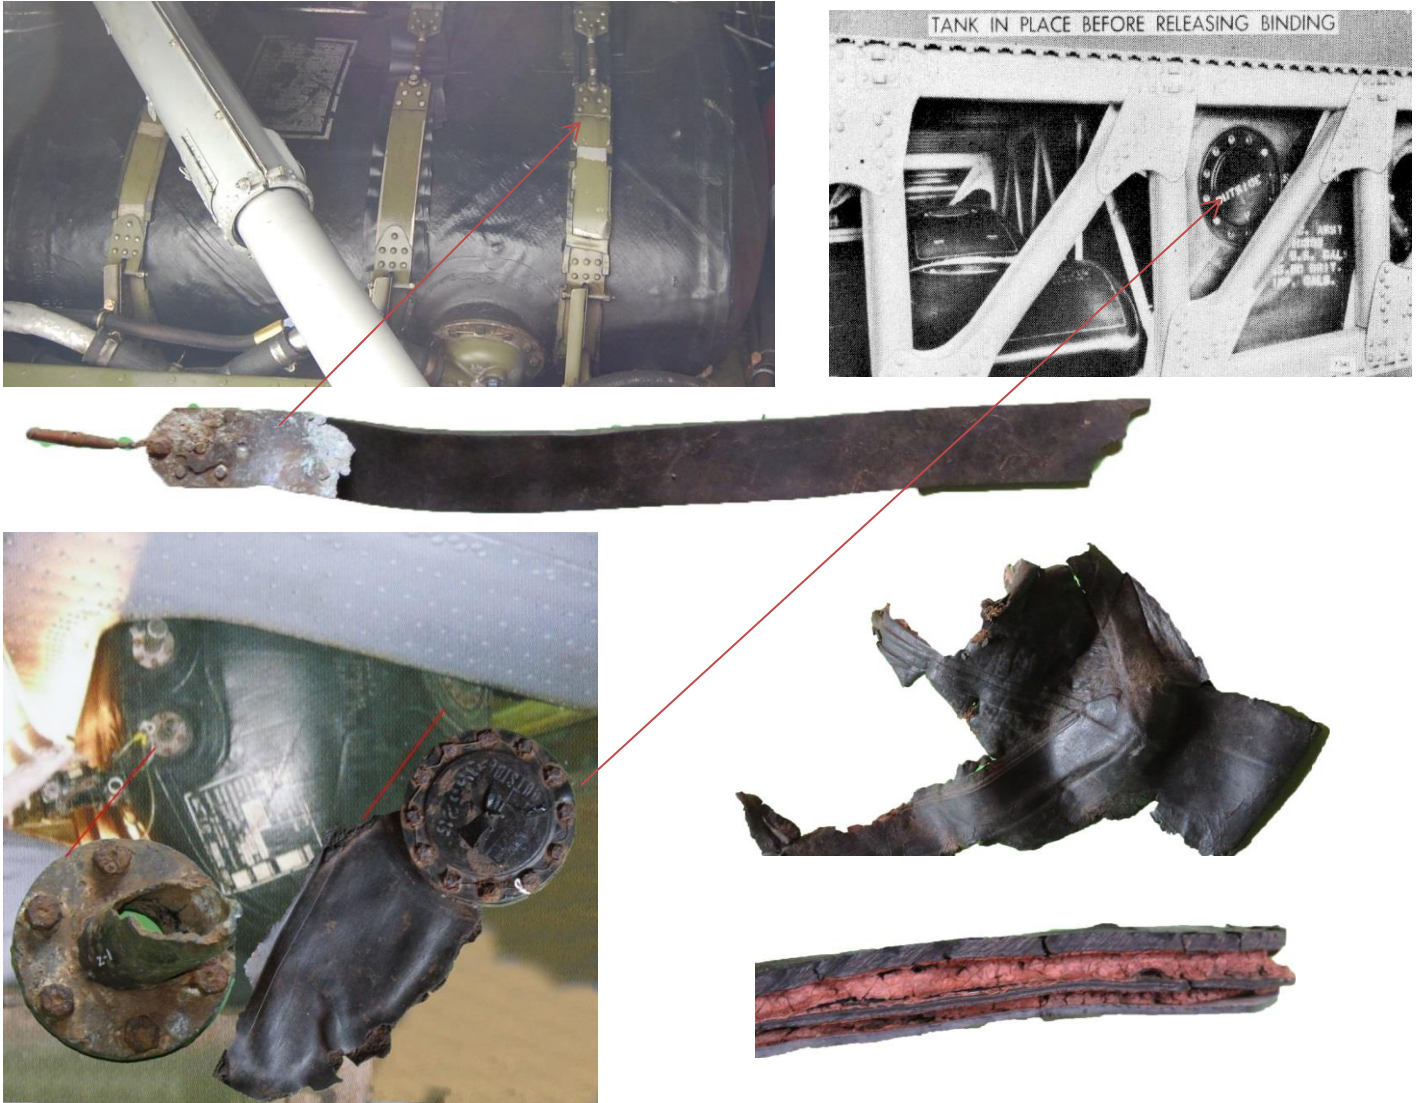
Figure 51-1-3, Fuel Bladder and strapping, web, WWIIBRPG

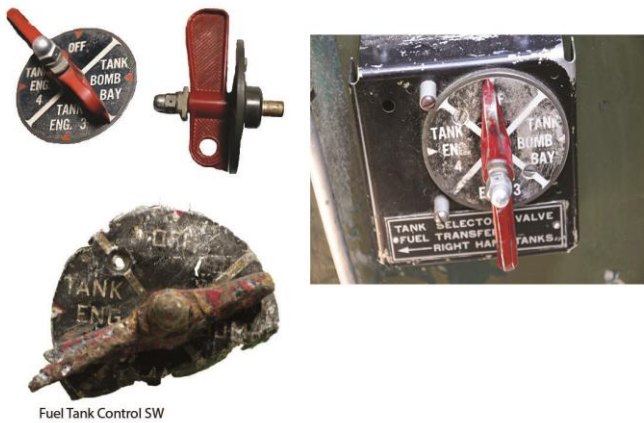
Figure 51-4 ,A profile photo of the self-sealing Fuel Bladder fragment, Z-3

Fuel Tank Control SW

Figure 51-5, Made by Gilfillan Bros, INC. Los Angeles Cal. WWIIBRPG, web

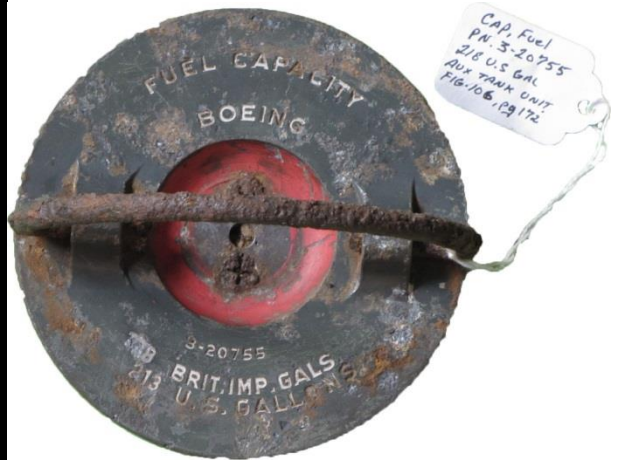
Figure 52-1, Fuel cap, Z-4, AN 01-20EG-04, WWIIBRPG

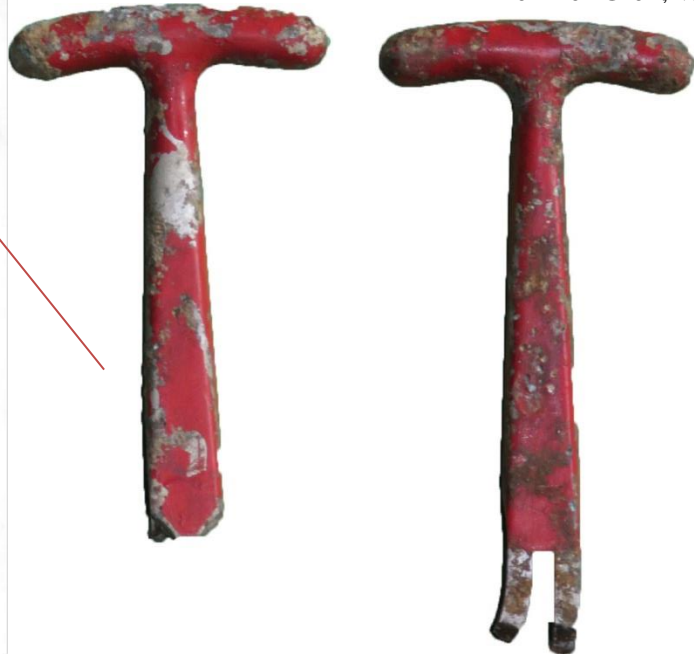
6. TOKYO TANKS SHUT-OFF VALVES.

Remote control handles, operating shut-off valves in the lines from each group of outer wing fuel tanks, are mounted below the door at the aft end of the bomb bay. Refer to Section I, paragraph 4, for operating instructions.

Figure 52-2, Erection and Maintenance Manual

Figure 52-3, Tokyo tank handles, WWIIBRPG

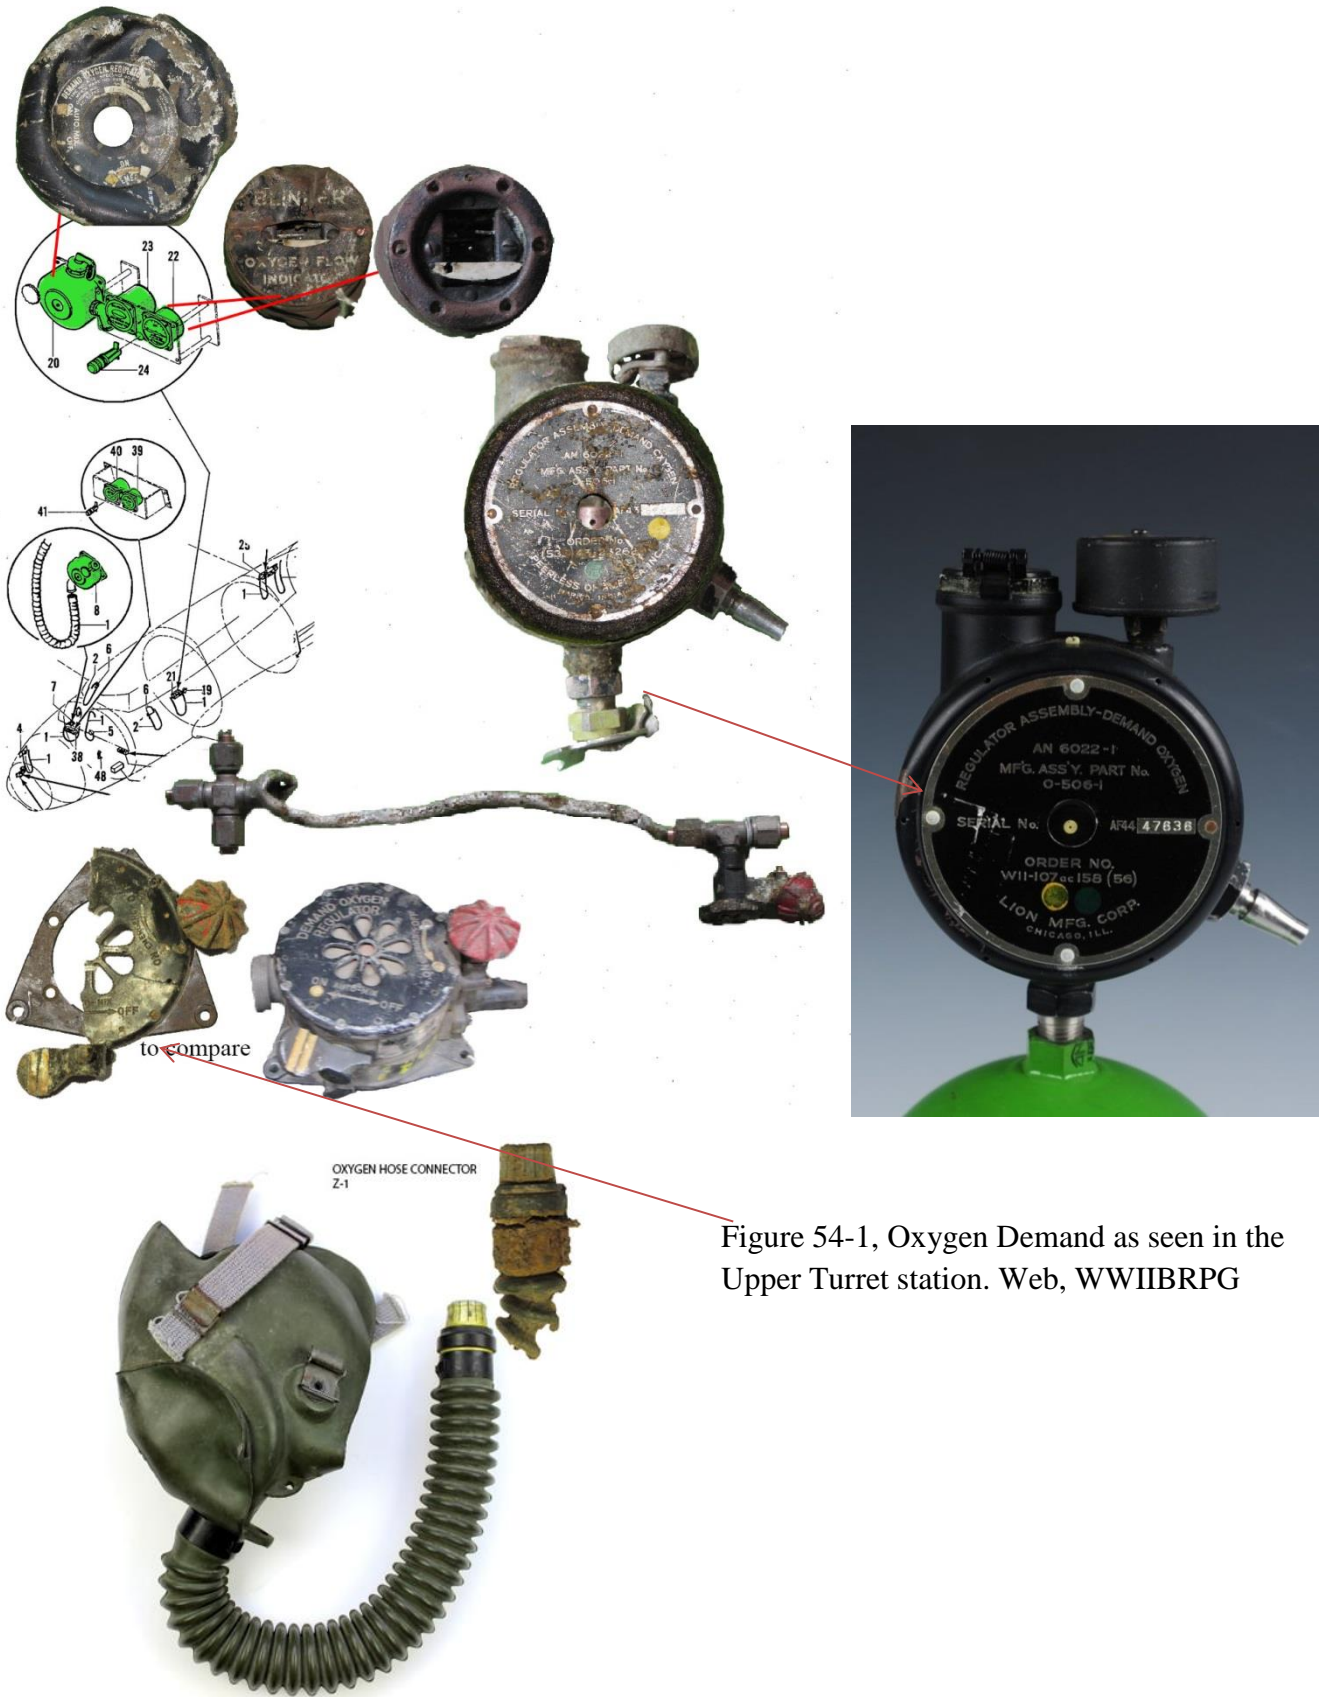
Figure 54-1, Oxygen Demand as seen in the Upper Turret station. Web, WWIIBRPG

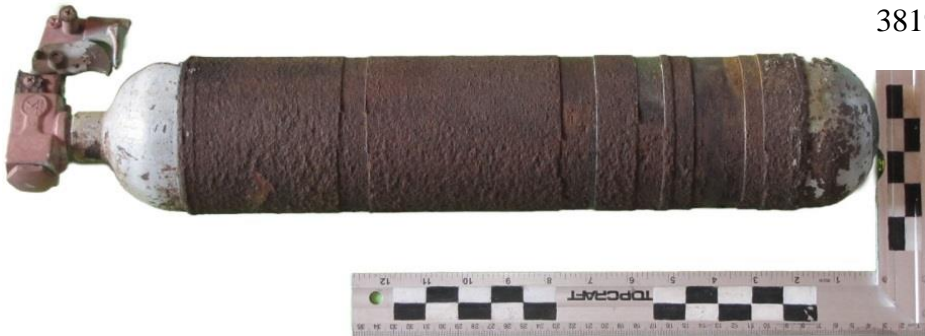
Figure 55-1, Walter Kidde Co Inc, 13-pound Fire Extinguisher, stock #4500-381924, (WWIIBRPG)

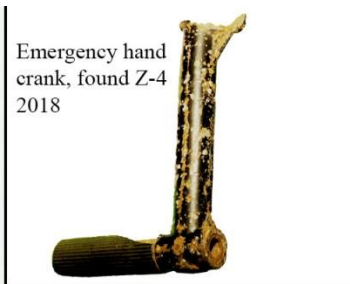
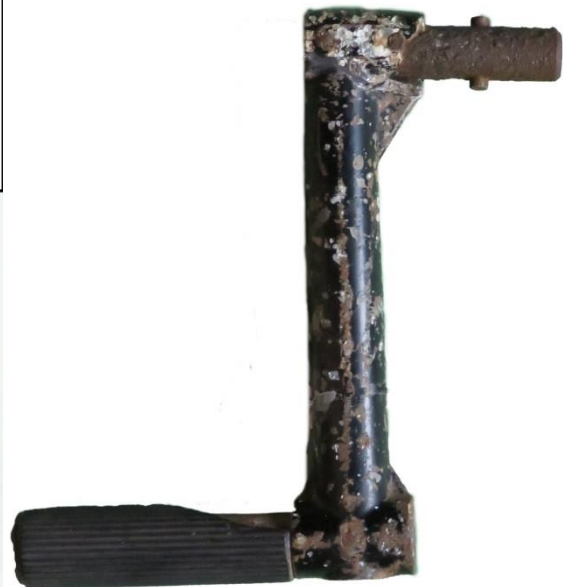
Emergency hand crank, found Z-4 2018

Figure 55-2, Emergency Hand Crank .WWIIBRPG, Pilots manual

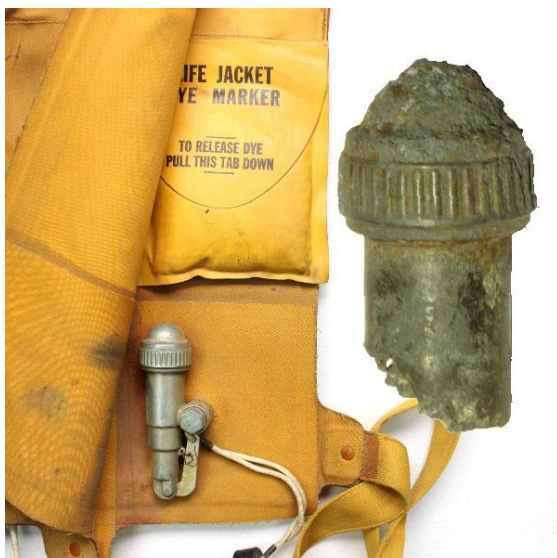
Figure 55-3, Compressed air release valve for Mae West Vest. Web, WWIIBRPG Copyright WWIIBRPG, 2020

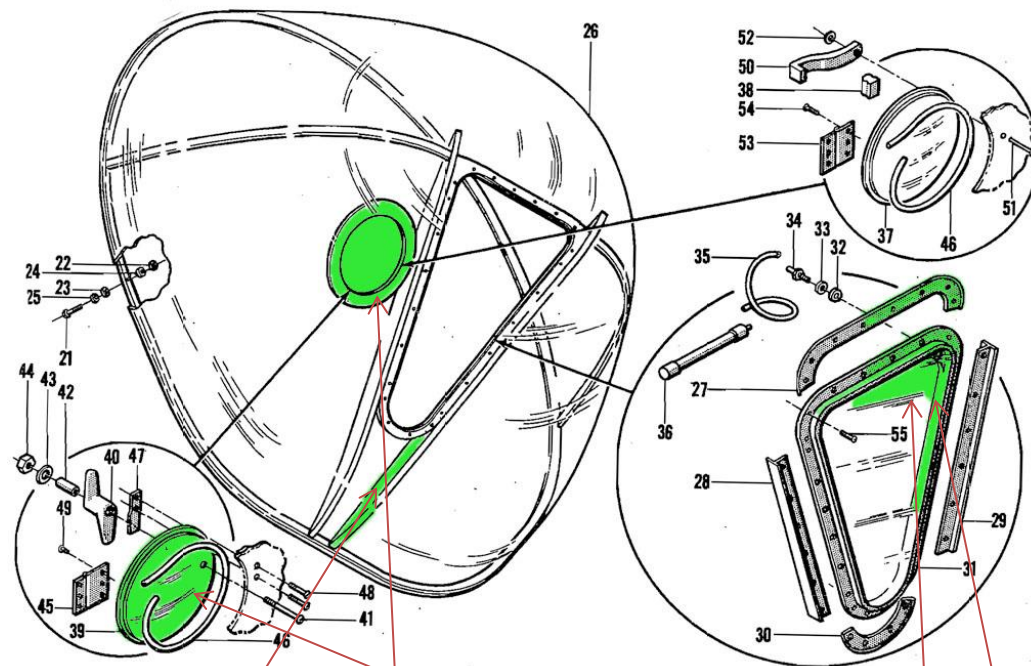
Figure 56-1. There were many pieces of Plexiglas and window frame/plastic found. Big thick pieces dubbed “ice cubes” probably came from the front nose section in front of the Bombardier station. The intriguing thing about Plexiglas and windows is, the feeling one gets as you see through a piece of the window that the crewmembers also last looked through. AN 01-20EG-4, WWIIBRPG

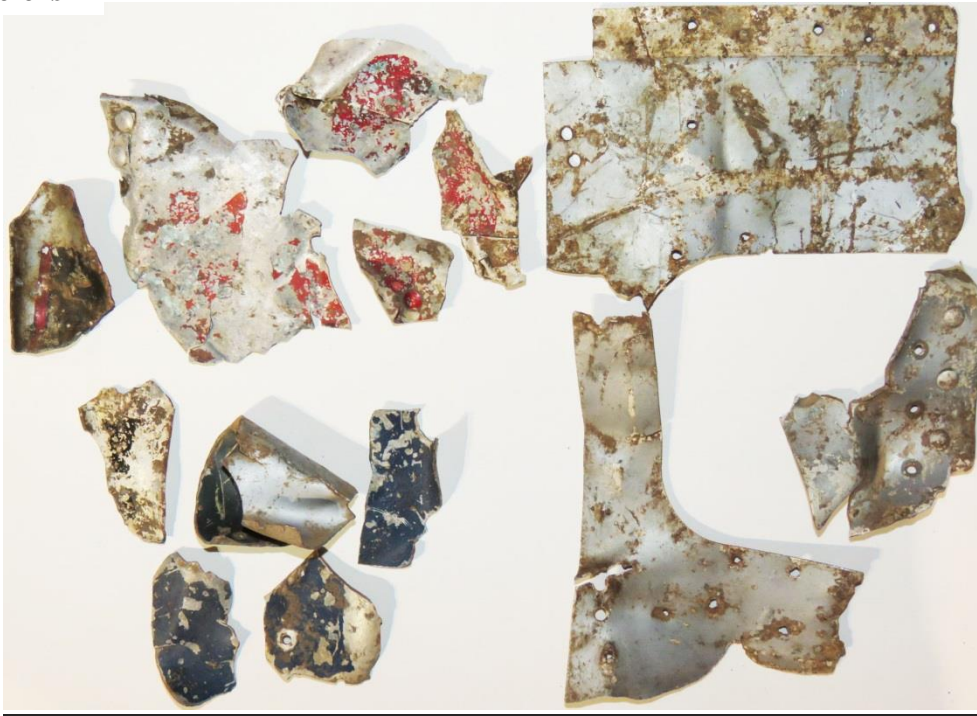
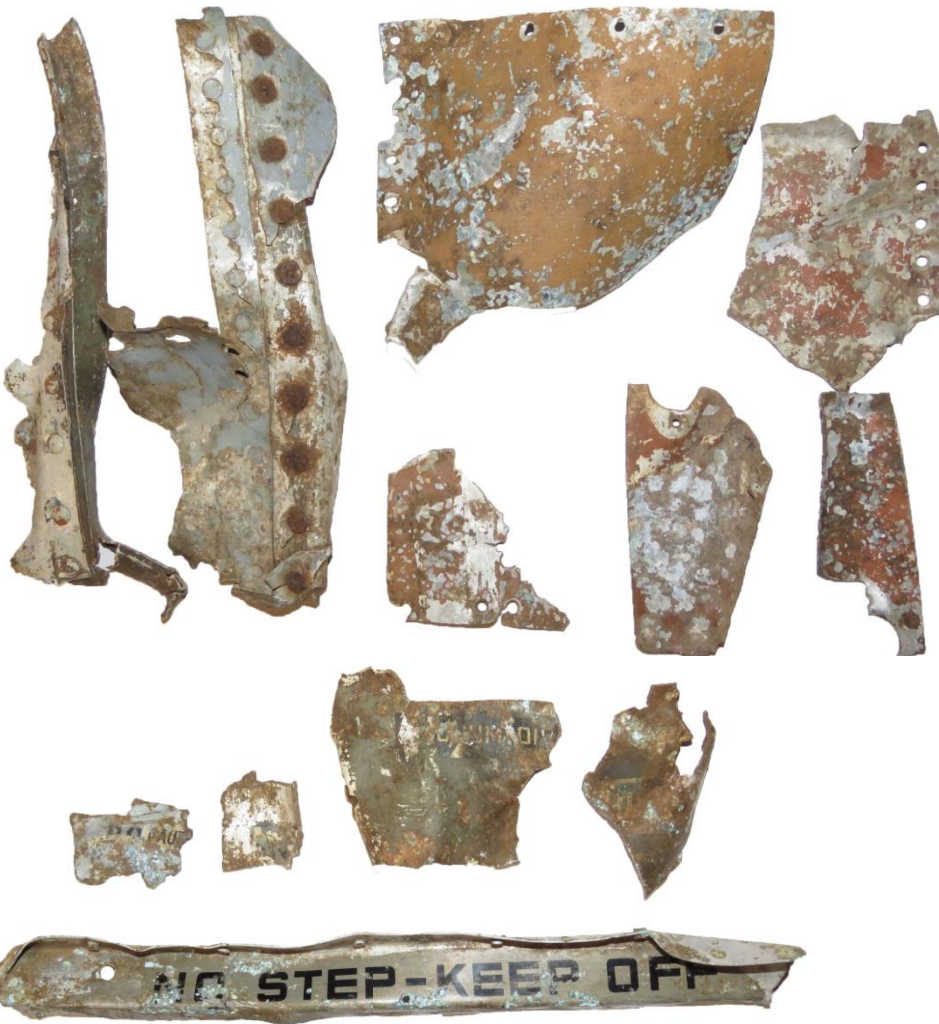
Figure 57-1, Several colors still clinging to the metal were found. Some red pieces appear to be bomb figures, most likely how many missions accomplished, according to records that would have been 64 since assigned to the 384<sup>th</sup>. Blue might come from the blue field with the star. There is also light blue, silver, and a mysterious mustard color, Squadron letters or camo?

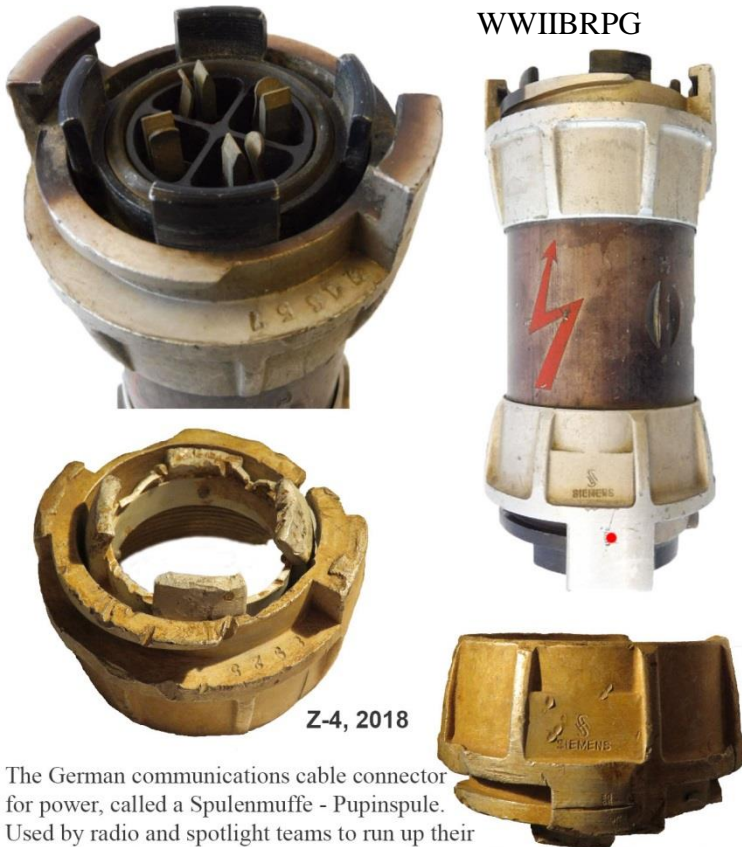
Figure 58-1, Electrical connector, Z-4, web, WWIIBRPG

The German communications cable connector for power, called a Spulenmuffe - Pupinspule. Used by radio and spotlight teams to run up their equipment. Thanks to our German member and colleague Pascal for tracking down what this was, it was a mystery to both of us, as I was certain it did not belong to the aircraft, but was from the 40s and at the location, the Germans may have had a spotlight, radar or a communications team there?
