# WWII BATTLEFIELD RESEARCH AND PRESERVATION GROUP

B-17G crash site concluding findings of Aircraft #44-6141, "Sneakin Deacon"  
United States Army Air Forces, 384th Bomber Group, 544th Bomber Squadron  
Date Found: 14 March 2018. Identified June 2020,  
Northwest of Weicherdange, Luxembourg

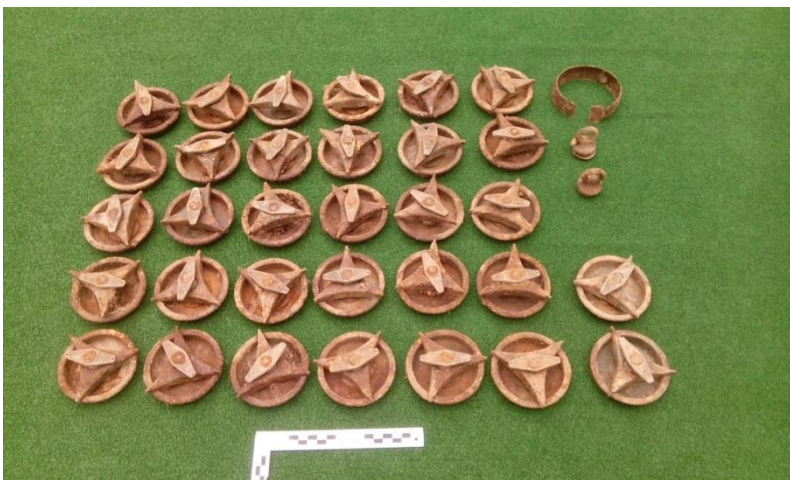
Figure 59-1-2, WWIIBRPG

One afternoon, a check of the field with a deep induction machine in hopes of finding something buried deeper began, maybe an engine or a .50 caliber machine gun was there so we could have something to identify the aircraft with. The survey began starting with walking the side of the field when a large signal sounded down the line, at first it was thought that there was a ground problem with the machine as nothing was expected in that area at the moment. Circling with another check of the ground, and again the machine indicated something. After digging down 45 centimeters a rust-colored ground showed, further checking revealed what looked to be an edge of something round. Having found a 500lb bomb in 2017 and other UXOs since caution lights went off. In 5 minutes, the mystery target was about to be identified; it was a 155mm artillery charge canister cover. Further recovery yielded 32 (37 kg) of them plus a couple of 155mm eyelet lifting plugs, also called “nose plugs” used to load the artillery shells on and off trucks or trailers.

Three weeks later, the same scenario as in Zone-4, this turned out to be 34 lifting plugs, weighing 38Kg. All items were donated to a local WWII club for displaying history. These may have belonged to an artillery unit assigned to the 26<sup>th</sup> Infantry Division, pushing towards Clervaux end of January 1945.

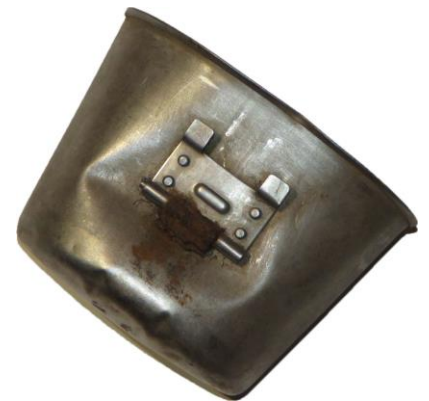
Figure 59-4, Found in an old trash site looking for engine parts, were this WWI canteen and mess top and WWII canteen cup. WWIIBRPG
